Figures 1A and 1B –
Radiographs showing
displaced unstable
supracondylar fracture
above the total knee
prosthesis; (1A) AP view,
(1B) lateral view.

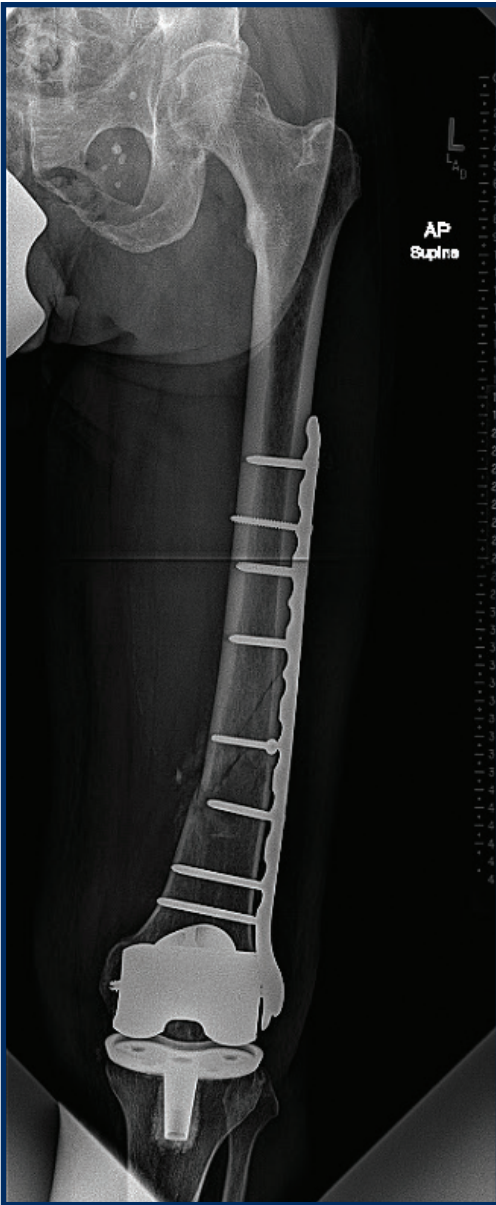
Figure 2 – Radiograph showing AP view after open reduction internal fixation of the supracondylar fracture using a 14 hole supracondylar locking plate.

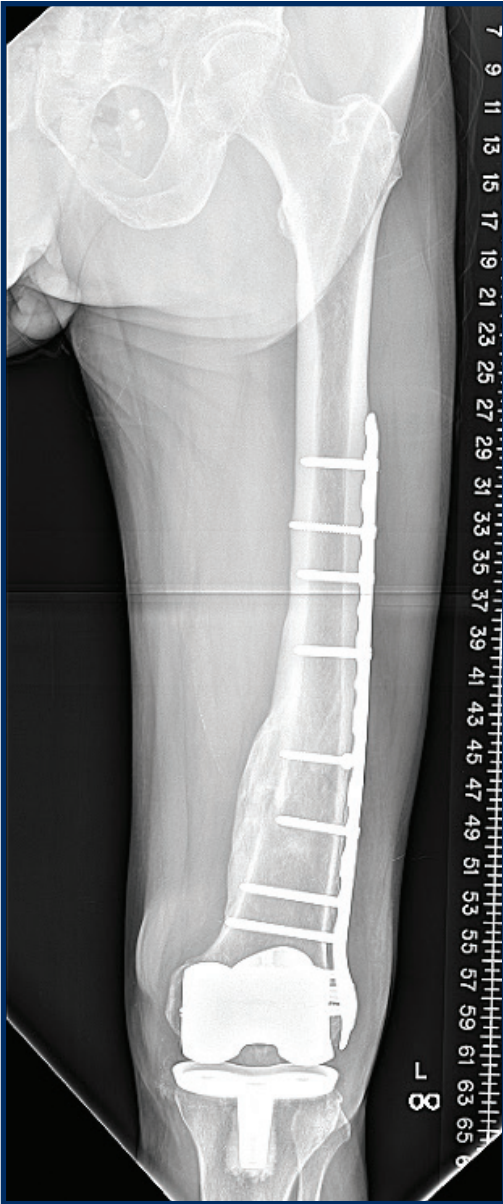
Figure 3 – Radiograph, AP view, at 4 months after supracondylar locking plate fixation, showing abundant callus formation permitting full weight bearing.
