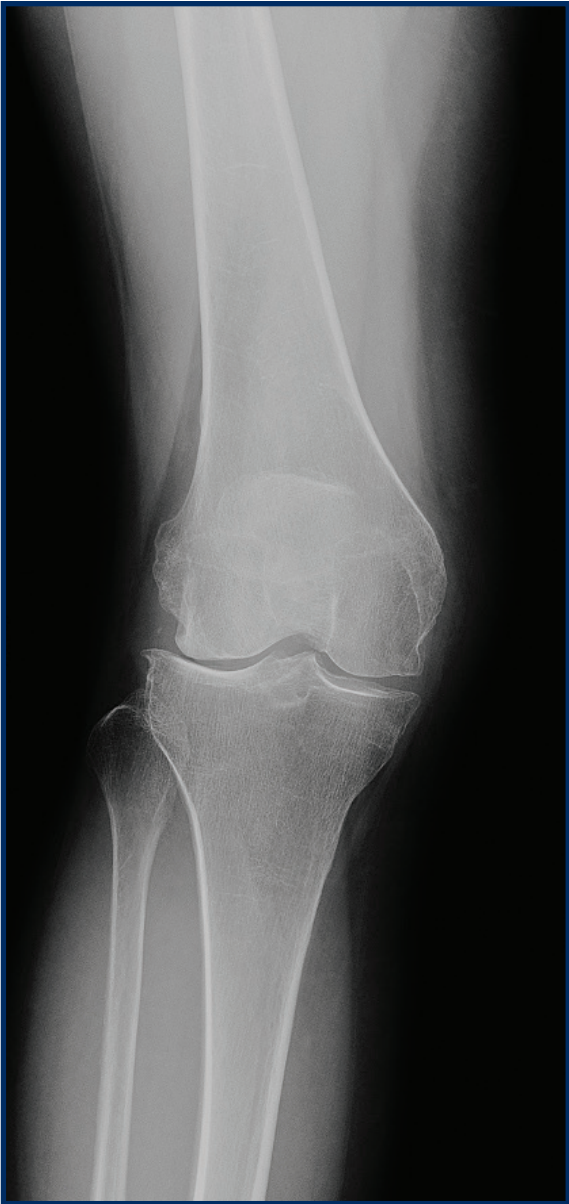
**Figure 1** – Pre-operative nonweight-bearing AP radiograph of the right knee, with valgus deformity and tricompartmental degenerative changes.

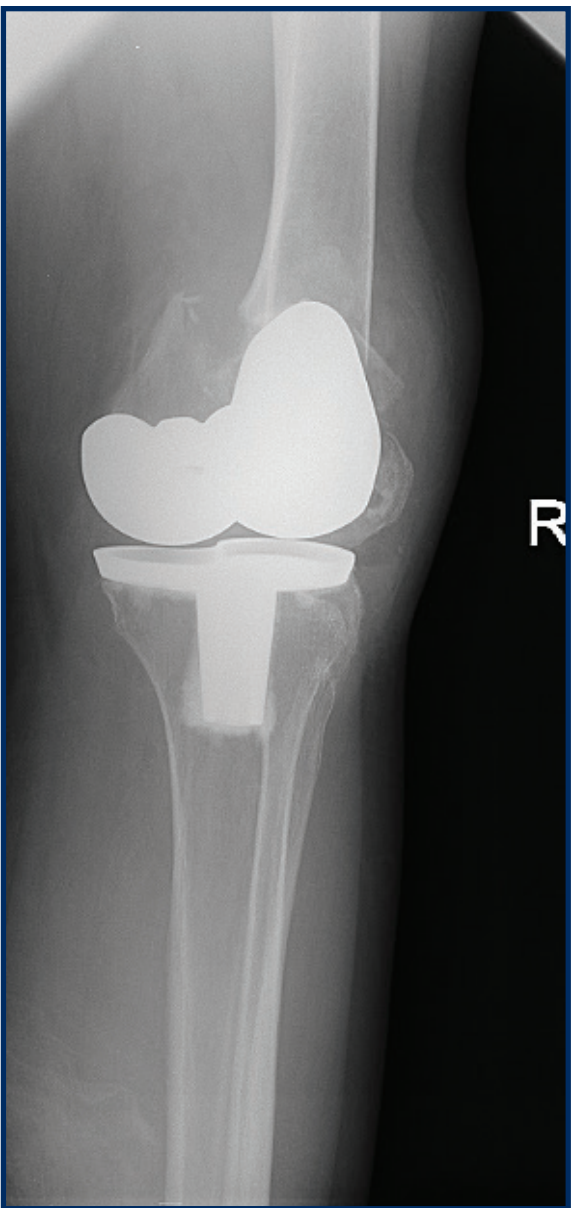
**Figure 3** – Radiograph four months after total knee replacement demonstrates a displaced supracondylar fracture at the level of the femoral prosthesis with considerable metaphyseal comminution.

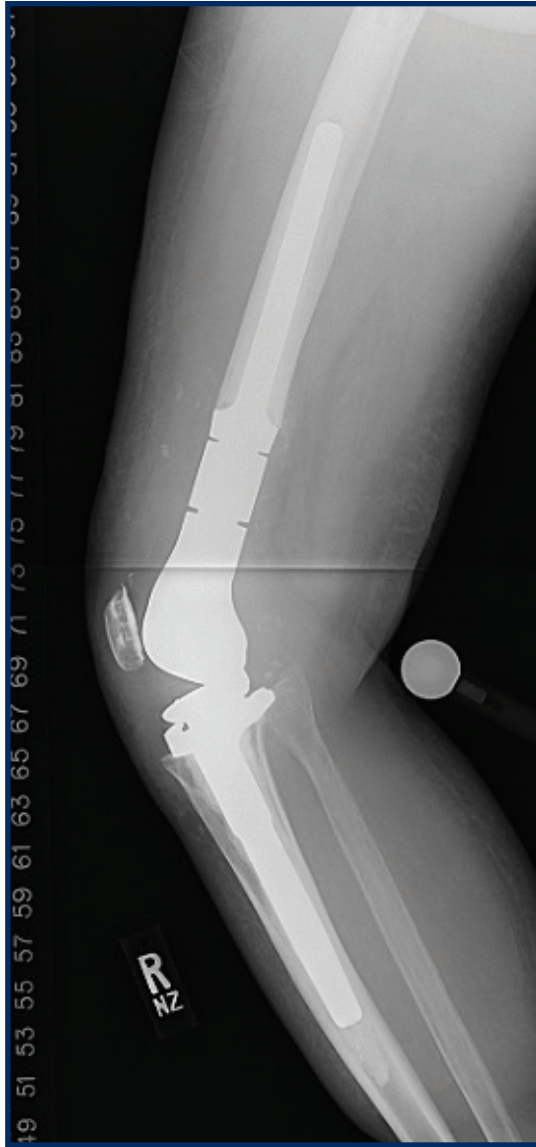
**Figures 4A and 4B –** AP (4A) and lateral (4B) radiographs demonstrate the modular, hinged distal femoral replacement with cemented intramedullary stems with restoration of the level of the natural joint line (4B).
