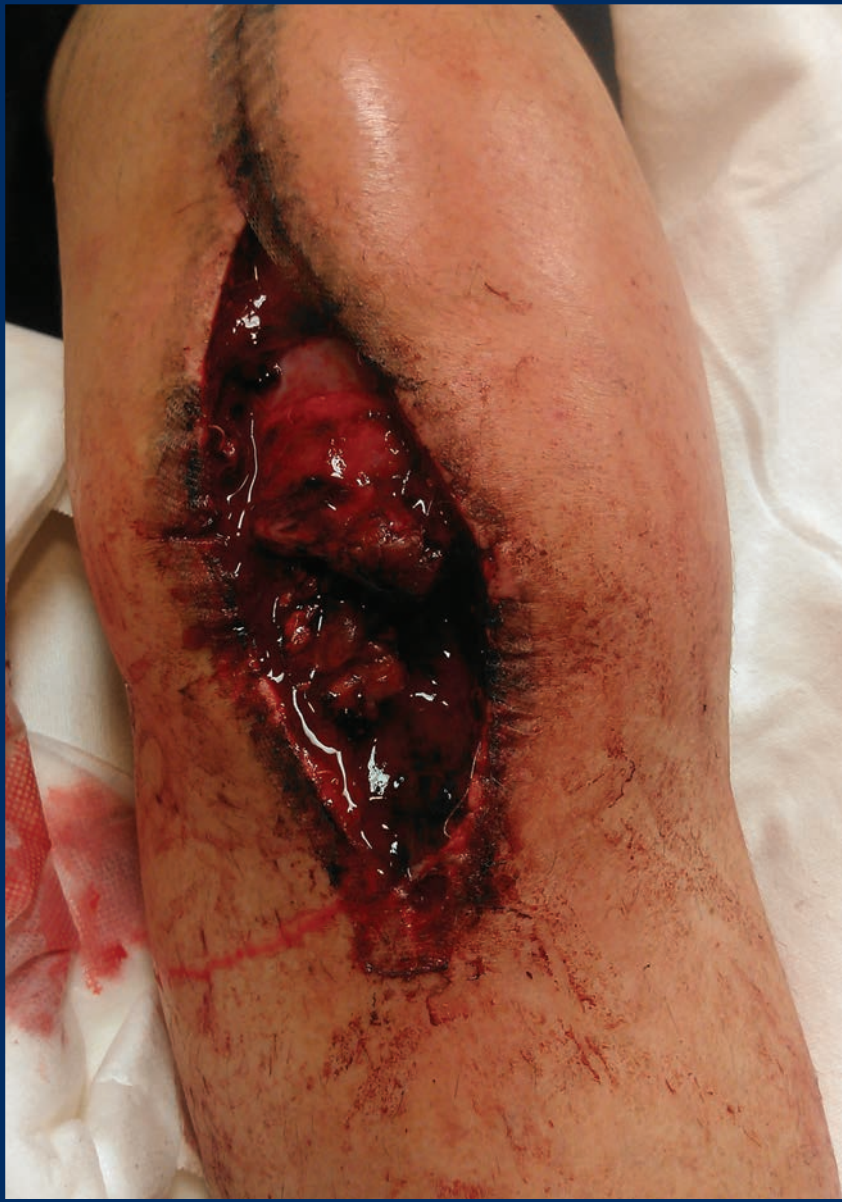
Figure 1 – Photograph showing dehiscence of the surgical wound and distal rupture of the patellar ligament.

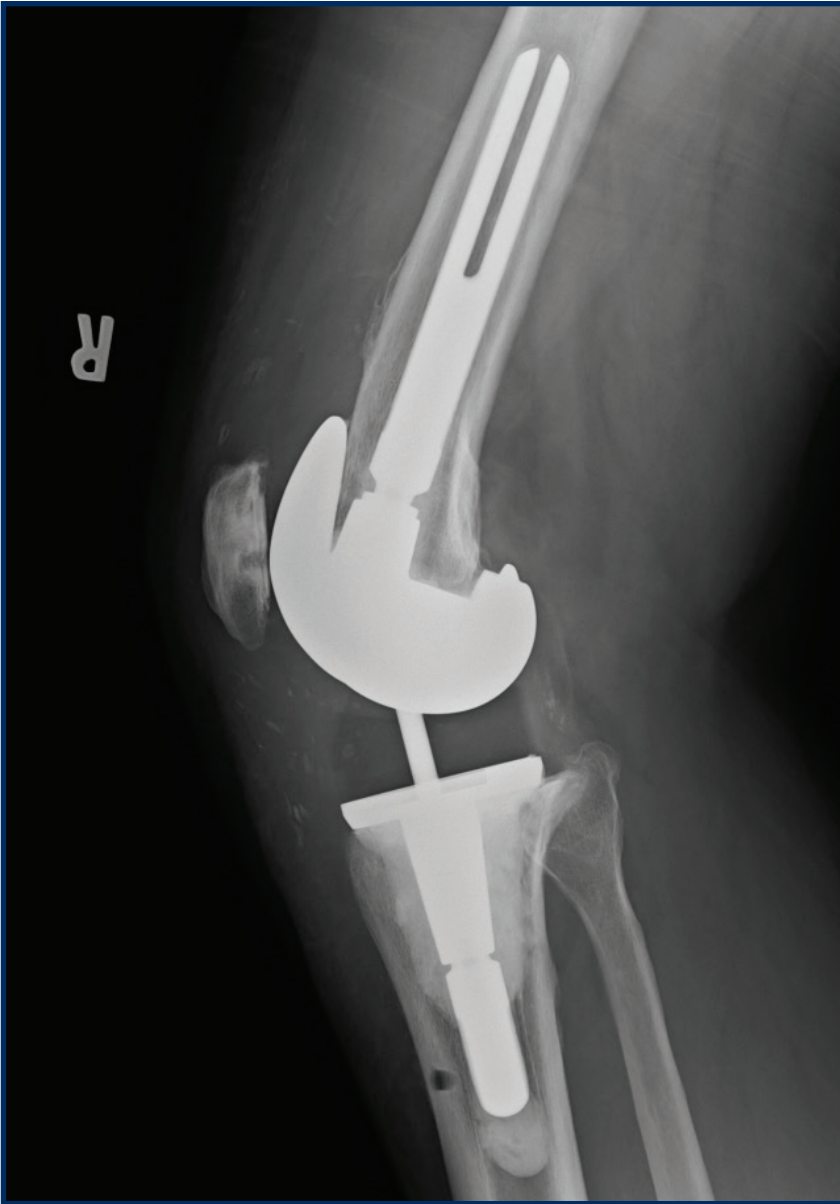
Figure 2 – Post-operative lateral radiograph of the right total knee replacement after reconstruction of the patellar ligament demonstrating restored patellar position and the bone tunnel in the anterior tibial cortex, site of passage of the allograft distally.

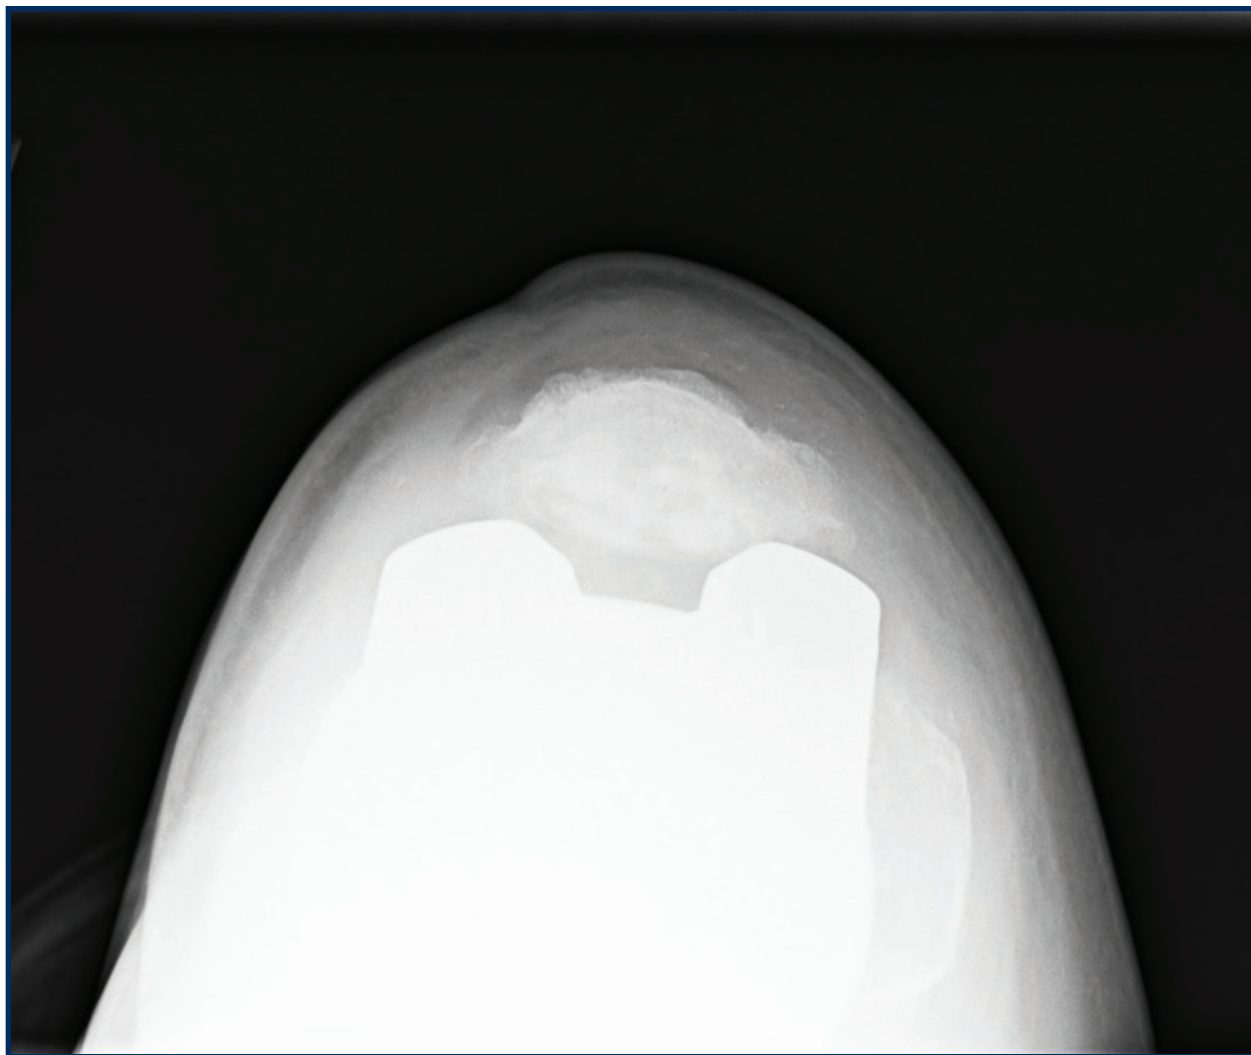
Figure 3 – Merchant view radiograph showing proper alignment of the patella after patellar ligament repair.
