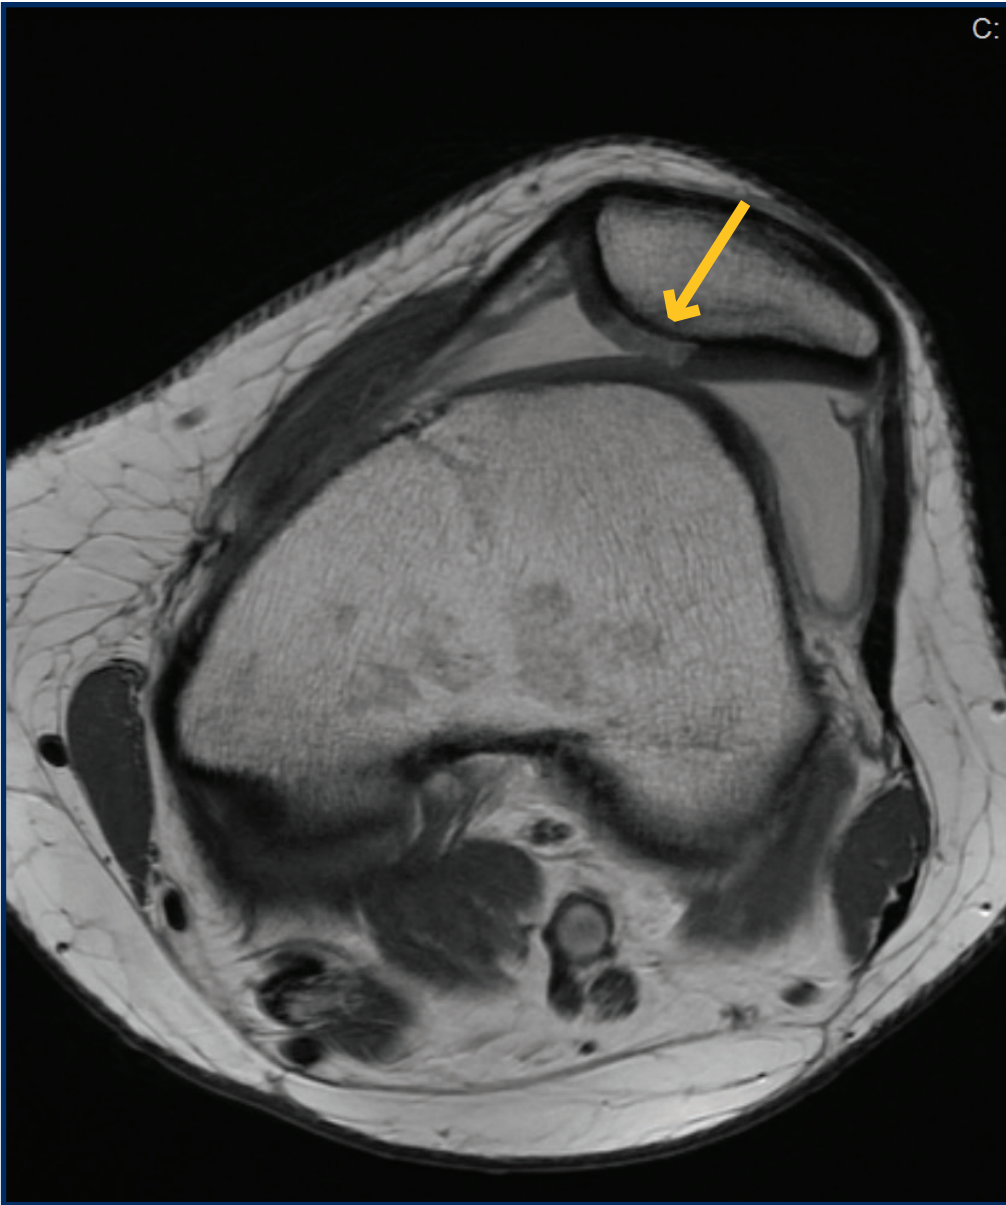
Figure 1 – Axial MRI depicting trochlear hypoplasia, lateral patellar subluxation, and central patellar cartilage lesion (arrow).
