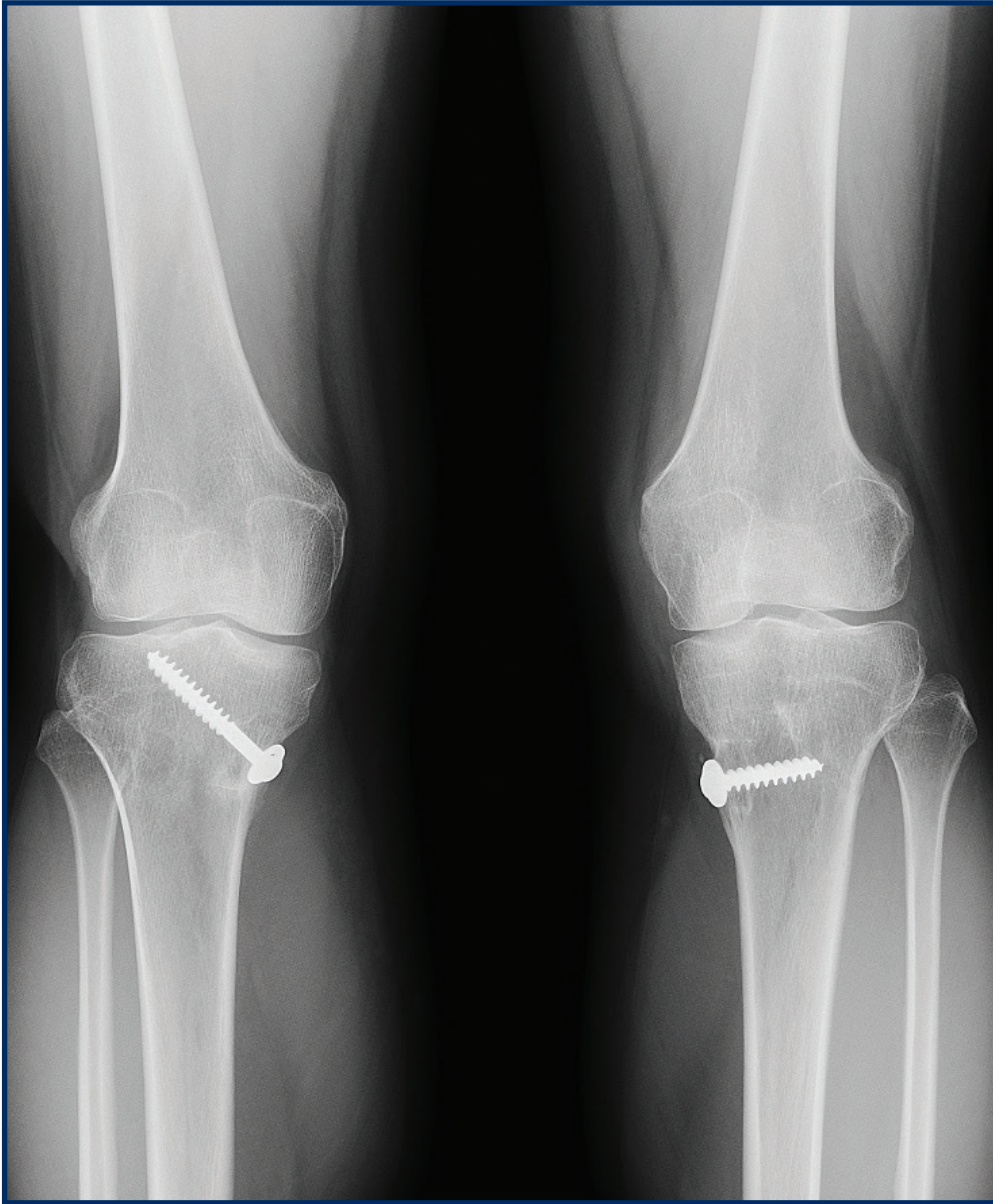
**Figure 1** – Preoperative radiograph demonstrating healed posteromedial tibial tubercle osteotomy sites.
