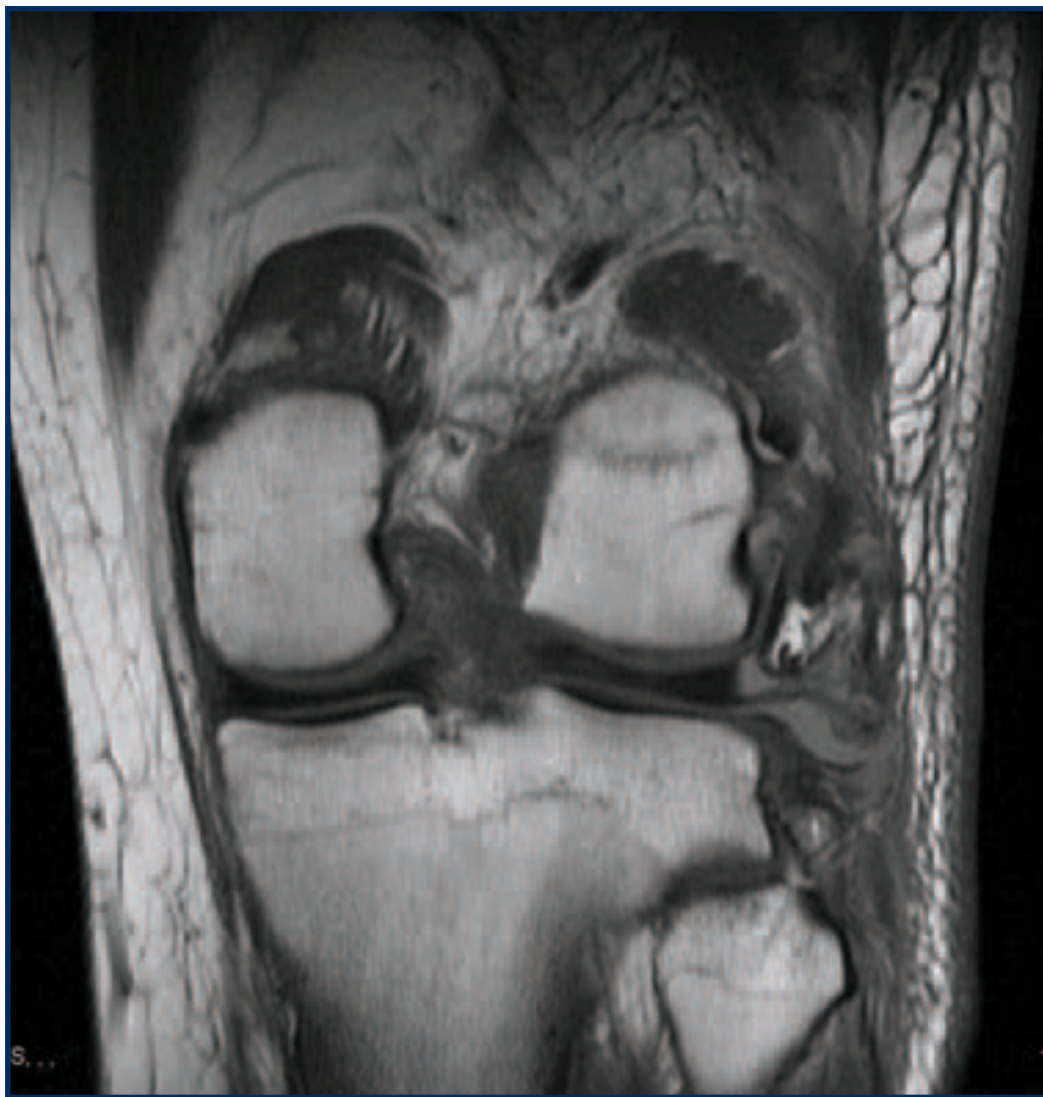
Figure 1 – Coronal MRI demonstrating bi-cruciate and lateral side disruptions.

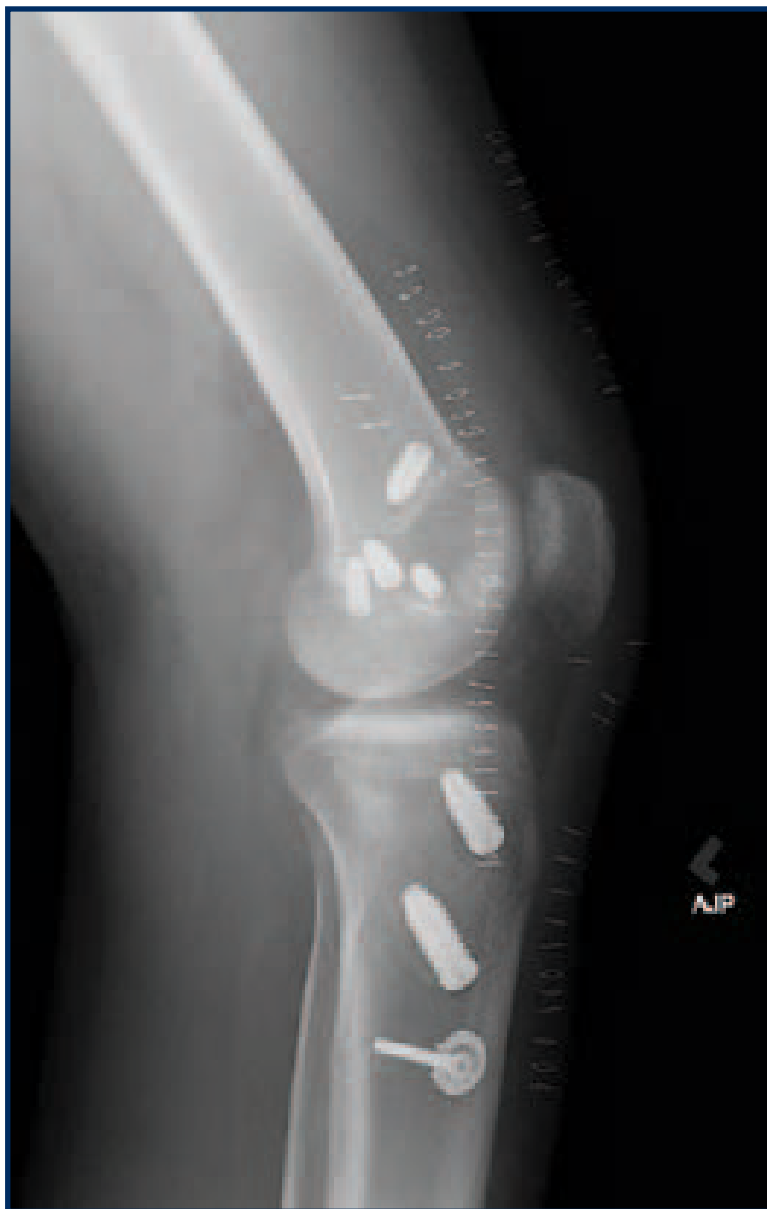
Figure 3 – Lateral x-ray left knee after reconstruction.
