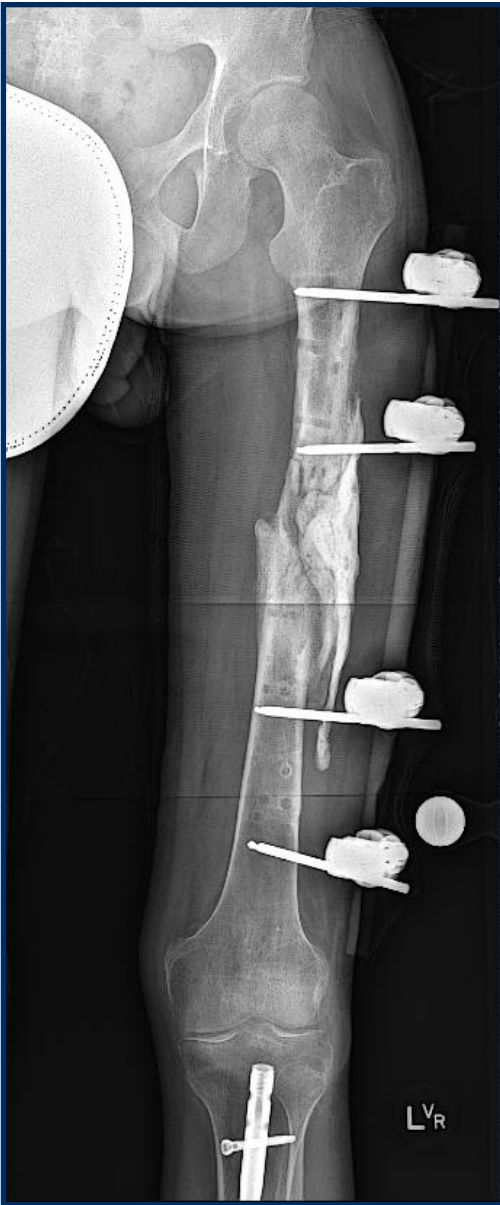
Figure 1 – X-ray of the left femur showing sclerotic bone ends and a cement spacer at the femur nonunion site.

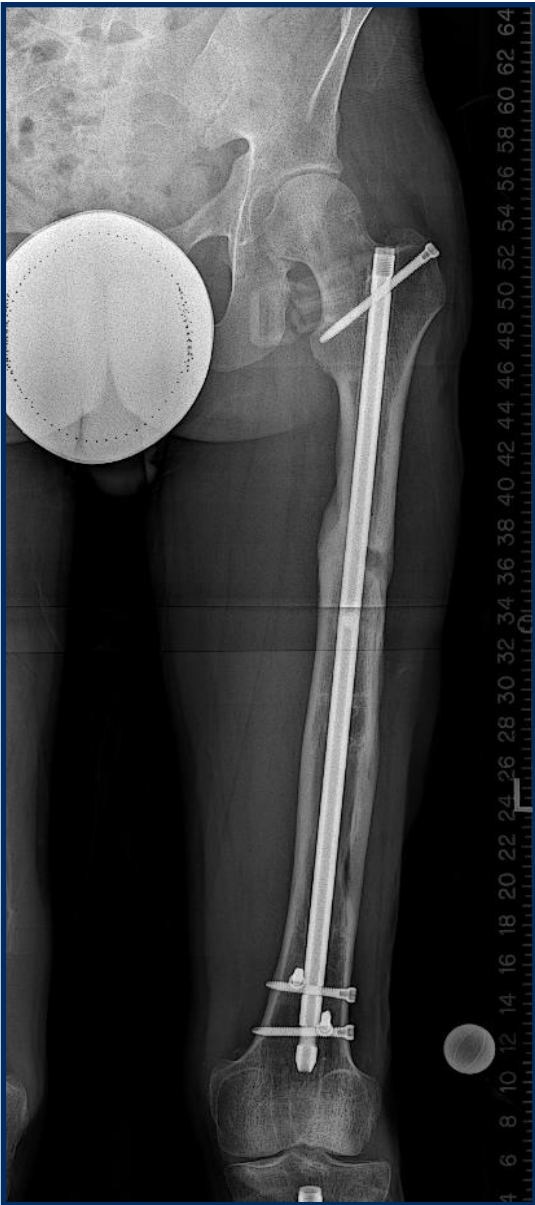
Figure 4 – Follow up x-ray shows a well healed docking site and circumferential healing of the regenerate with thick cortices.
