History: 77 year old man with left TKA seven years prior. New onset pain and sensation of instability after recent fall in May 2014.

Diagnosis: Fracture of the polyethylene tray

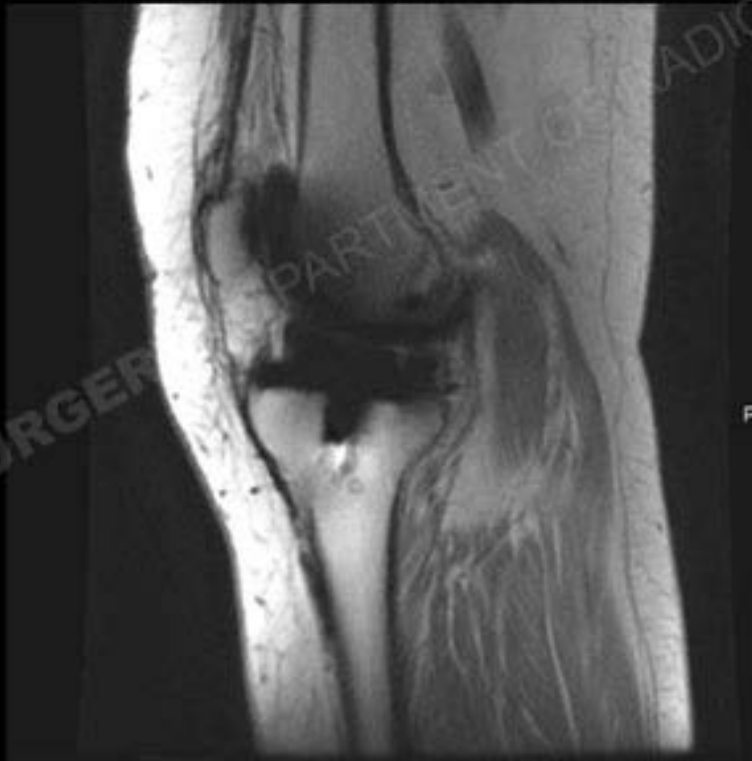
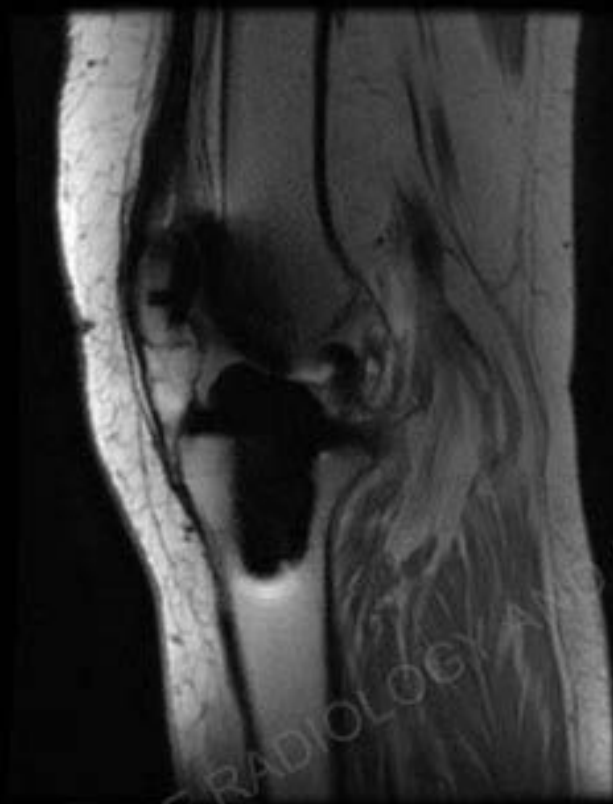
Sagittal IR and Sagittal PD at same location

Sagittal PD through PCL

All images shown are from sequences employing multi-acquisition variable resonance image combination technique. MRI is from 5/2014.

The multiple sets of radiographs demonstrate a mild loss of medial joint space width from 2006 to 2009 but then with a stable appearance through 2012. Then, in 5/2014 there is a precipitous loss of medial joint space with increased valgus of the femoral component. This becomes even greater in 7/2014. MRI shows a very subtle area of fluid intensity and subtle offset at the posterior medial aspect of the polyethylene tray. The PCL is attenuated in this PCL retaining prosthesis.

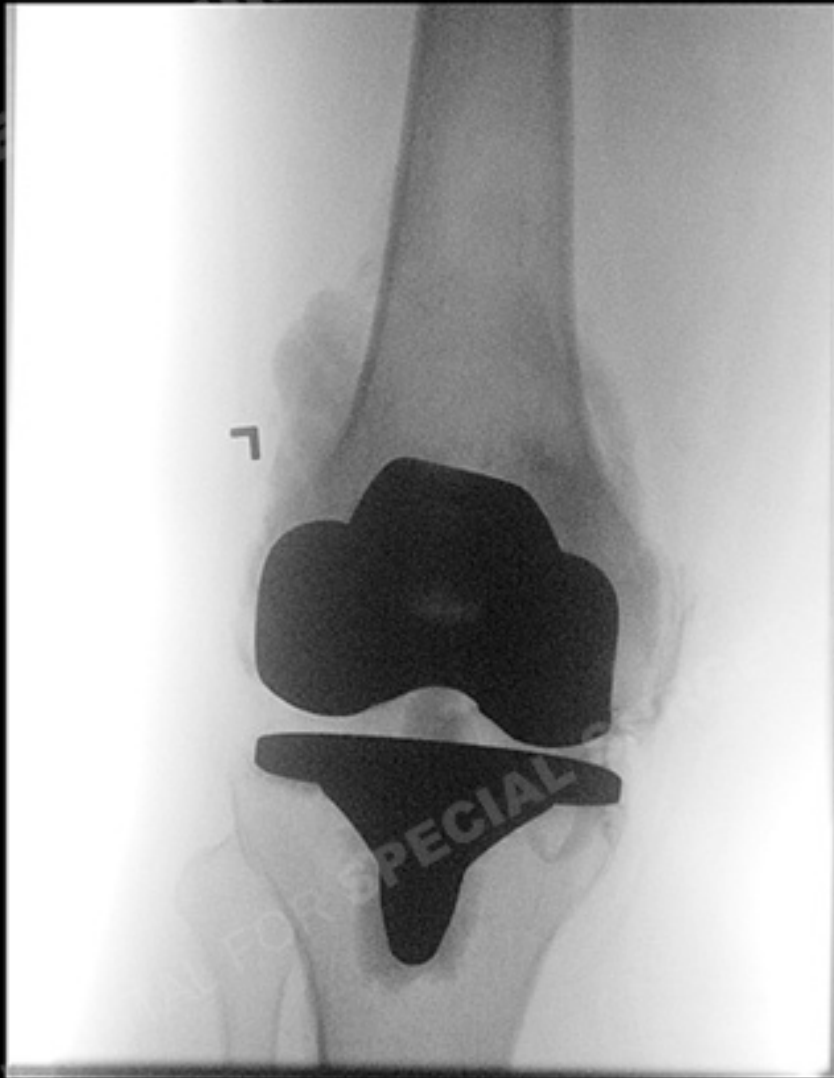
Representative image from arthrogram

The arthrogram is the same day as the radiograph it is compared to showing a difference in alignment with and without weight bearing. Particularly the post contrast CT study shows an abnormal configuration to the polyethylene tray and multiple low attenuation bodies in the joint and a Baker's cyst.

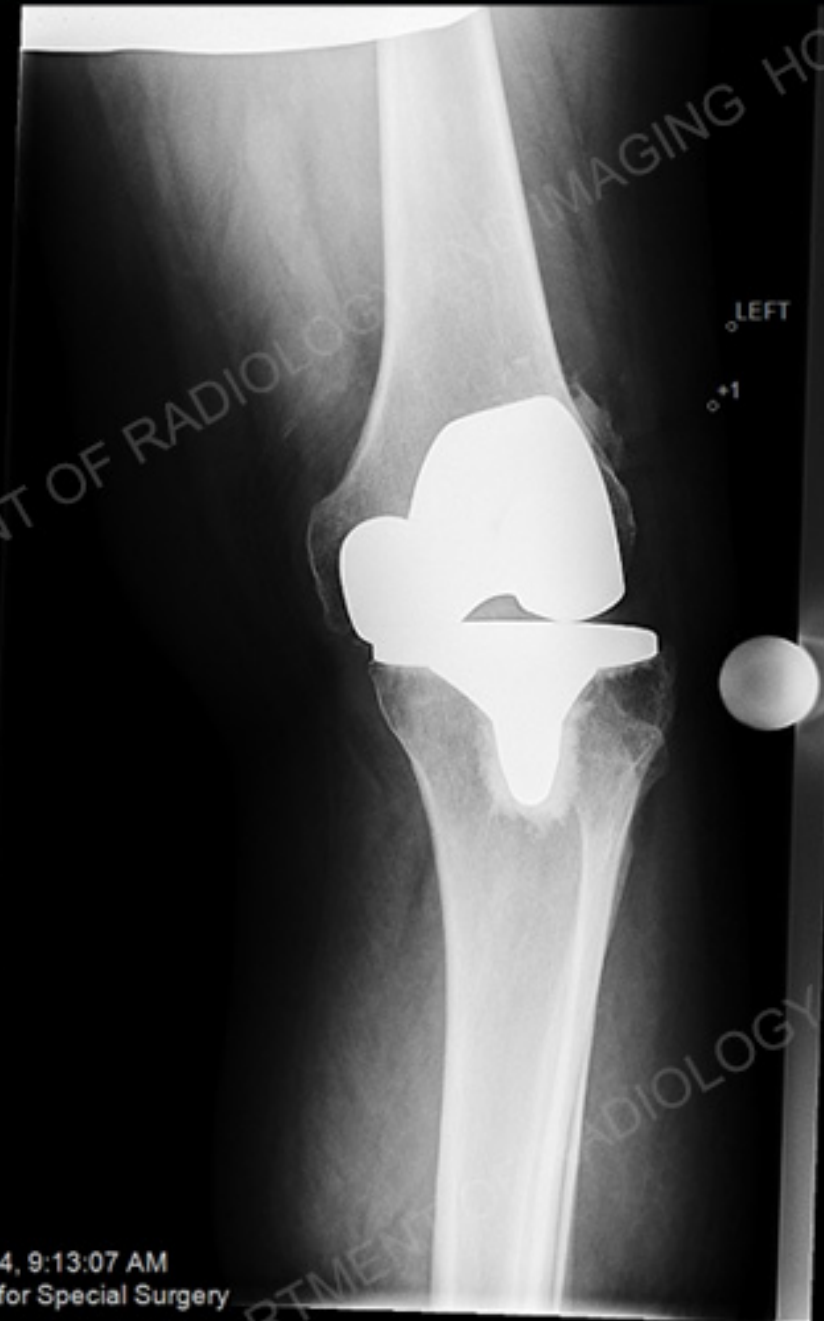
Upright AP view

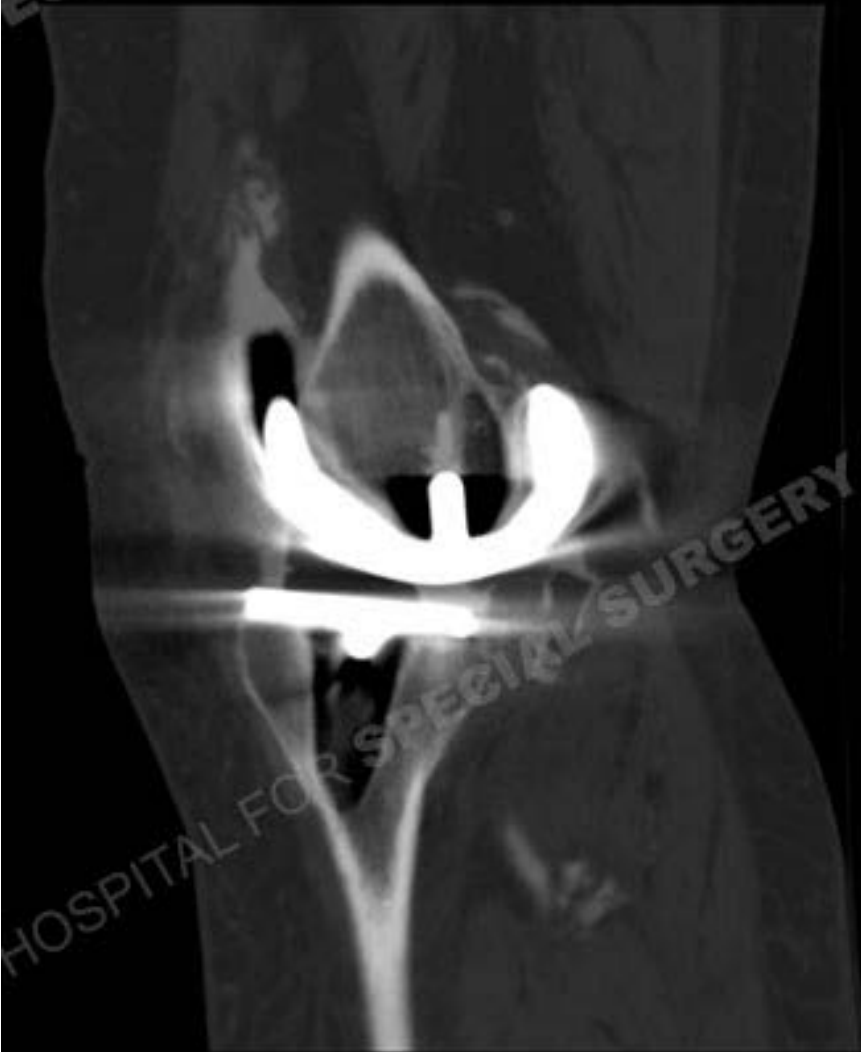
Sagittal reformatted and axial images of CT performed following a myelogram on the same day as previously shown CT.

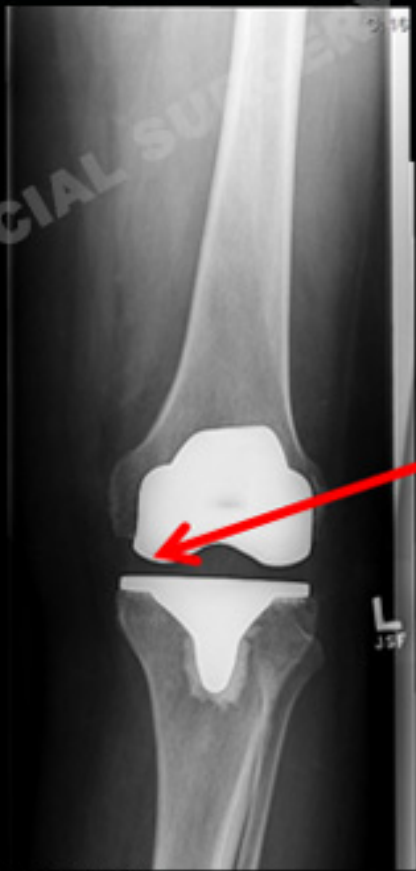
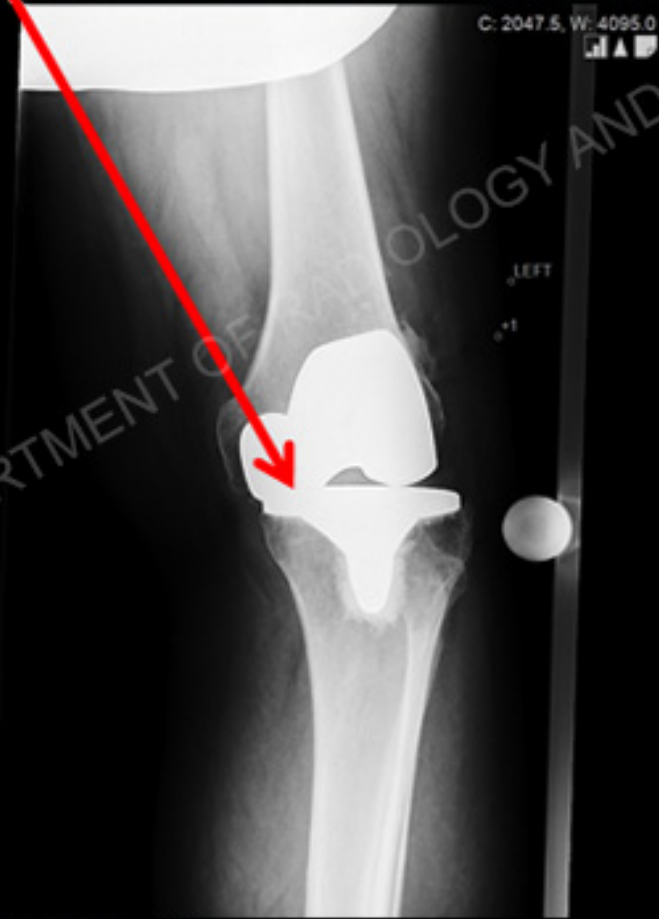
Loss of medial joint space with increased valgus alignment

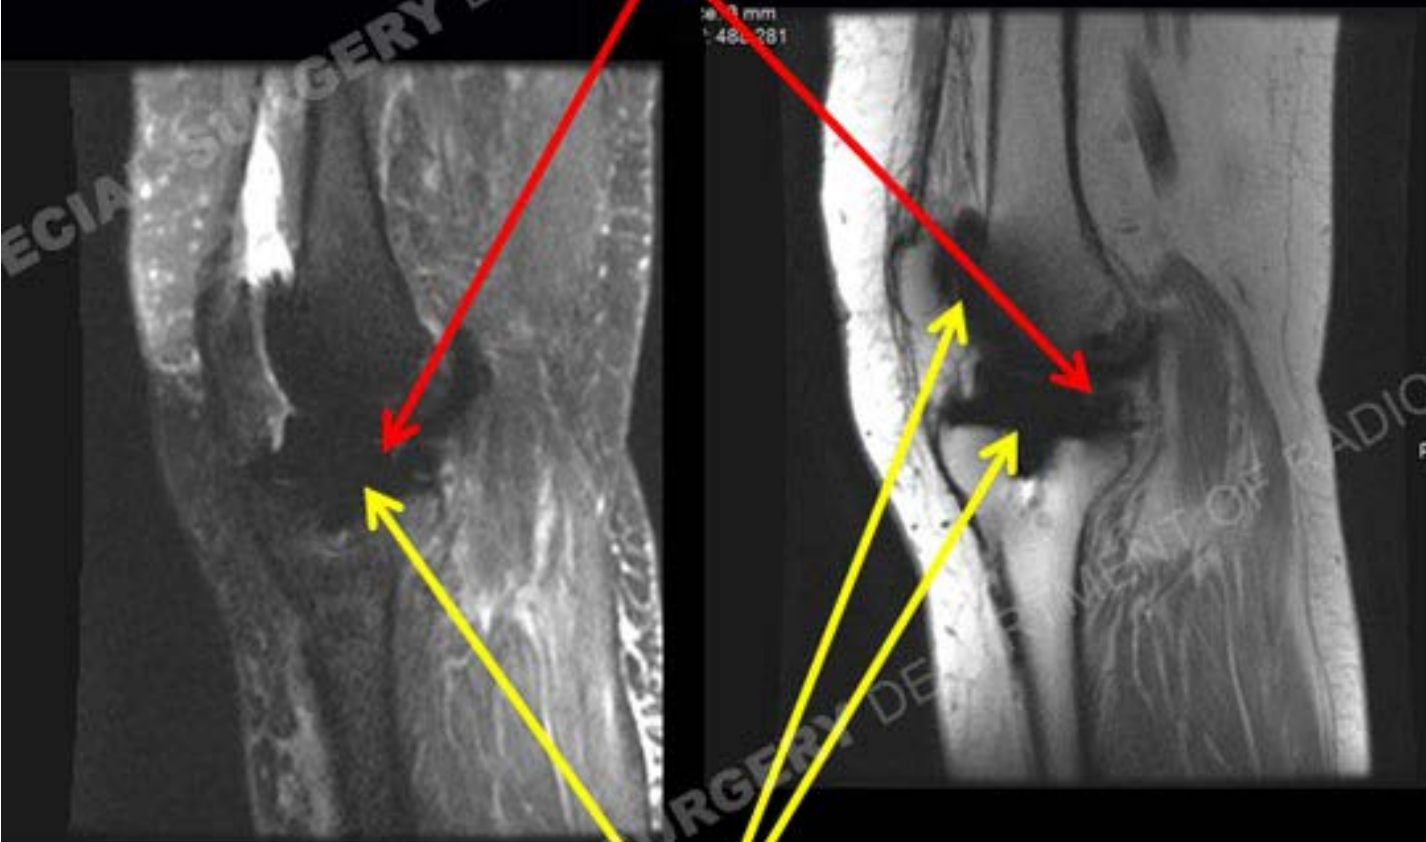
Subtle, high signal and abnormal contour of the polyethylene tray

Normal metal appearance

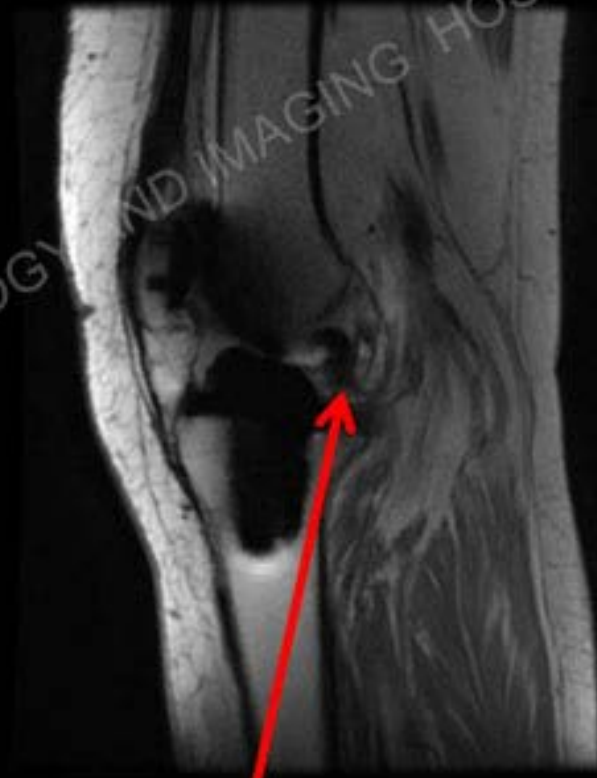
Attenuated PCL

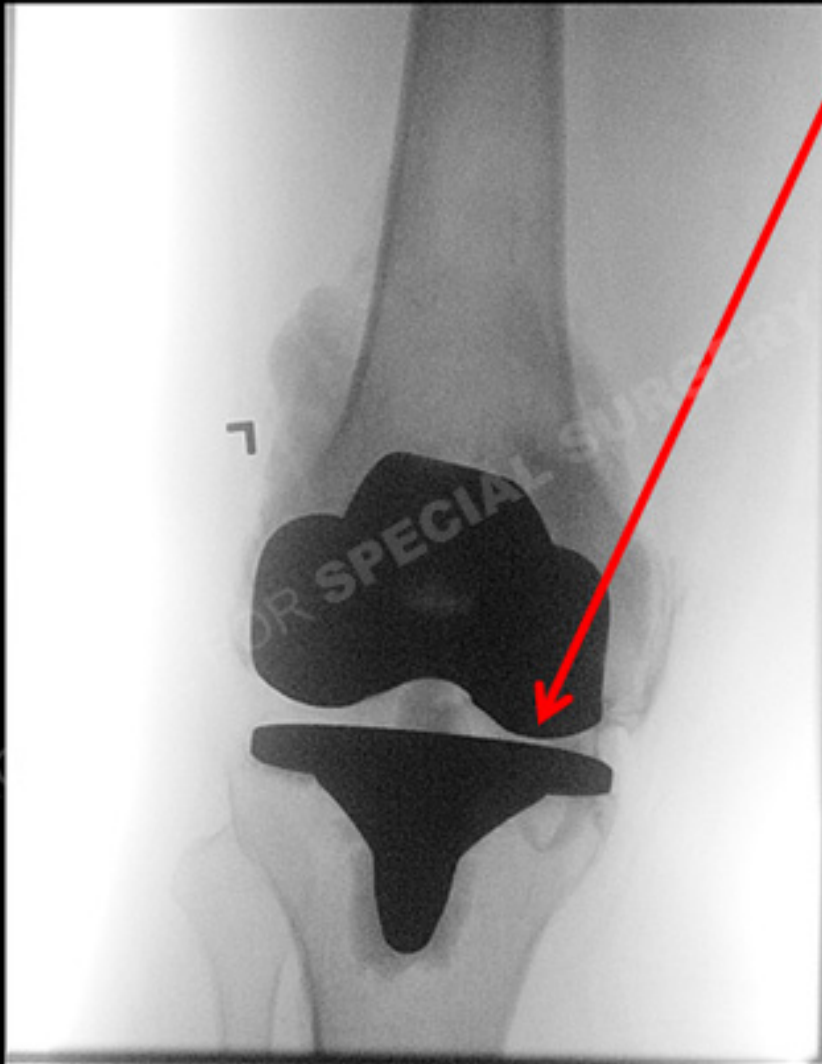
Change in position from non-weightbearing arthrogram to weight bearing radiographs (please note medial and lateral are switched between the images).

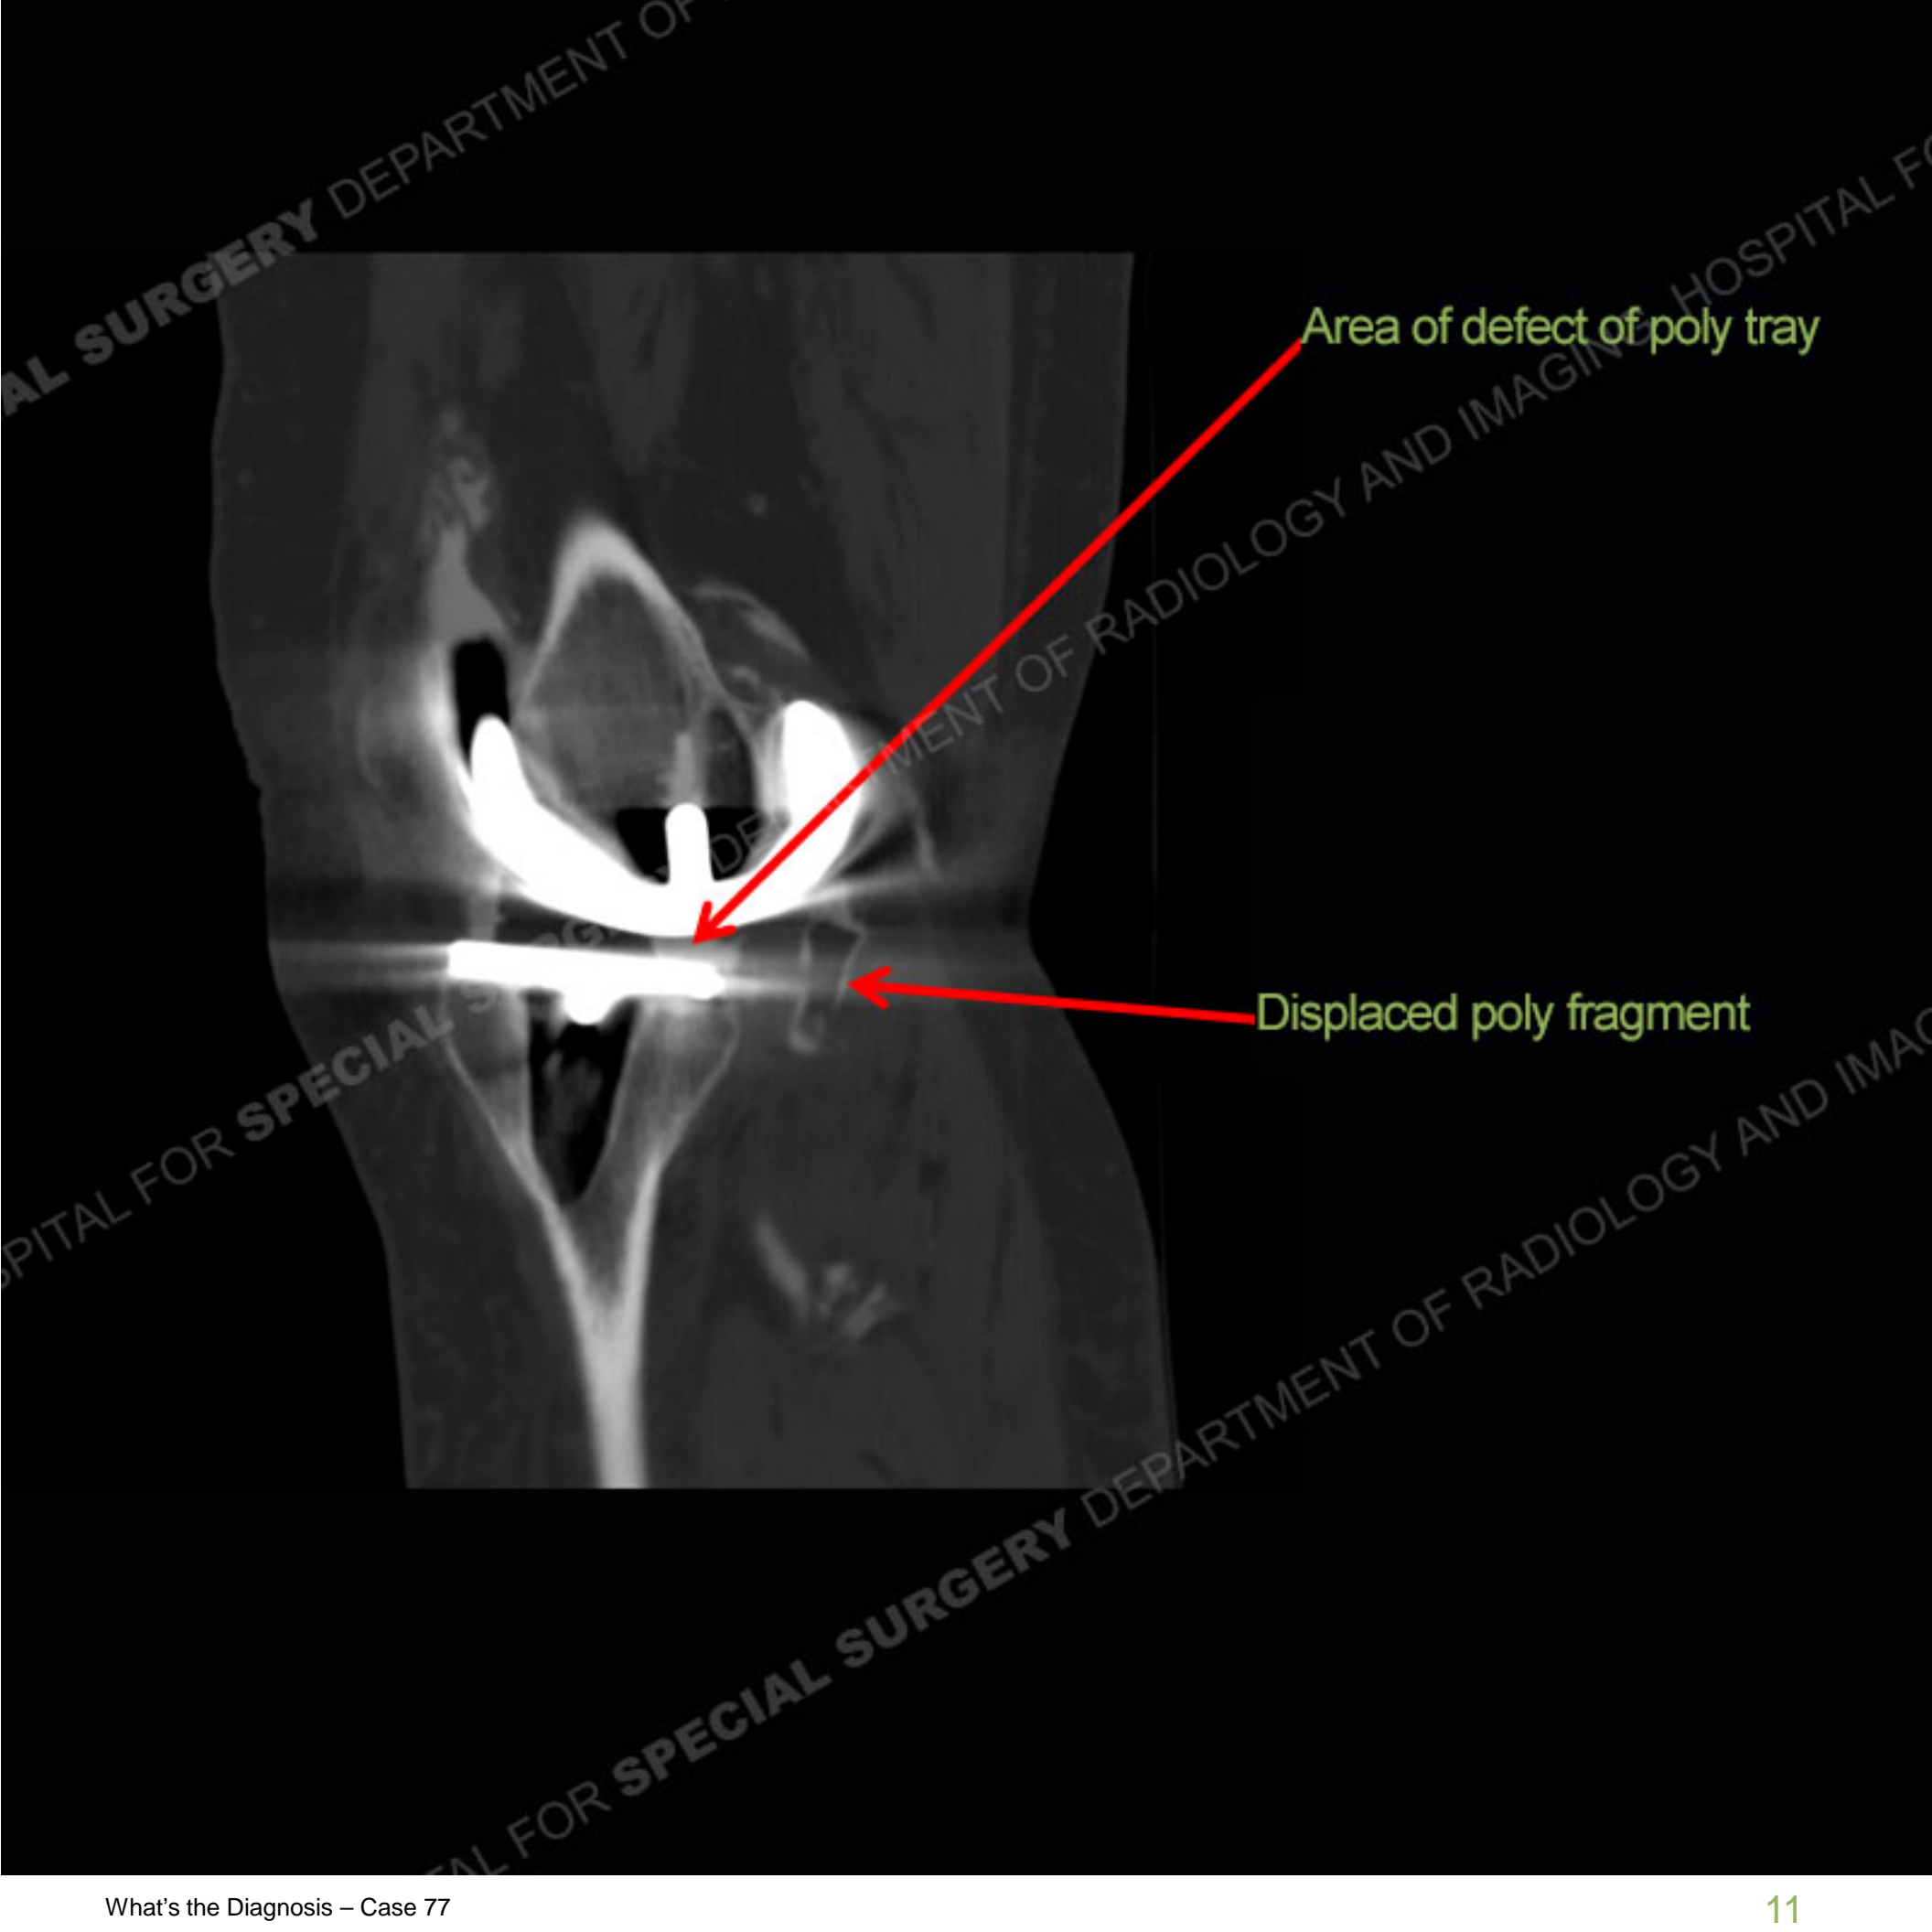
Area of defect of poly tray

Displaced poly fragment

Total knee arthroplasty has a variety of known complications inclusive of infection, periprosthetic fracture, and osteolysis/loosening. Wear of the polyethylene tray yields particles inducing osteolysis which is not infrequently seen but an actual fracturing of the poly tray is rare. As in this case the defect can lead to abnormal mechanics that are perceived as instability as the metal condyle falls in and out of the defect. Perhaps in this case the findings are so much more conspicuous on the CT arthrogram as compared to the MRI because there has been interval displacement of the fragments. Had the displaced fragments been present at the time of the MRI they would be able to be perceived particularly given the recent, enhanced techniques. This patient is scheduled for revision surgery.
