History: 58 year old man with THA done 2.5 years now with audible squeaking with walking

Diagnosis: Ceramic Liner Fracture

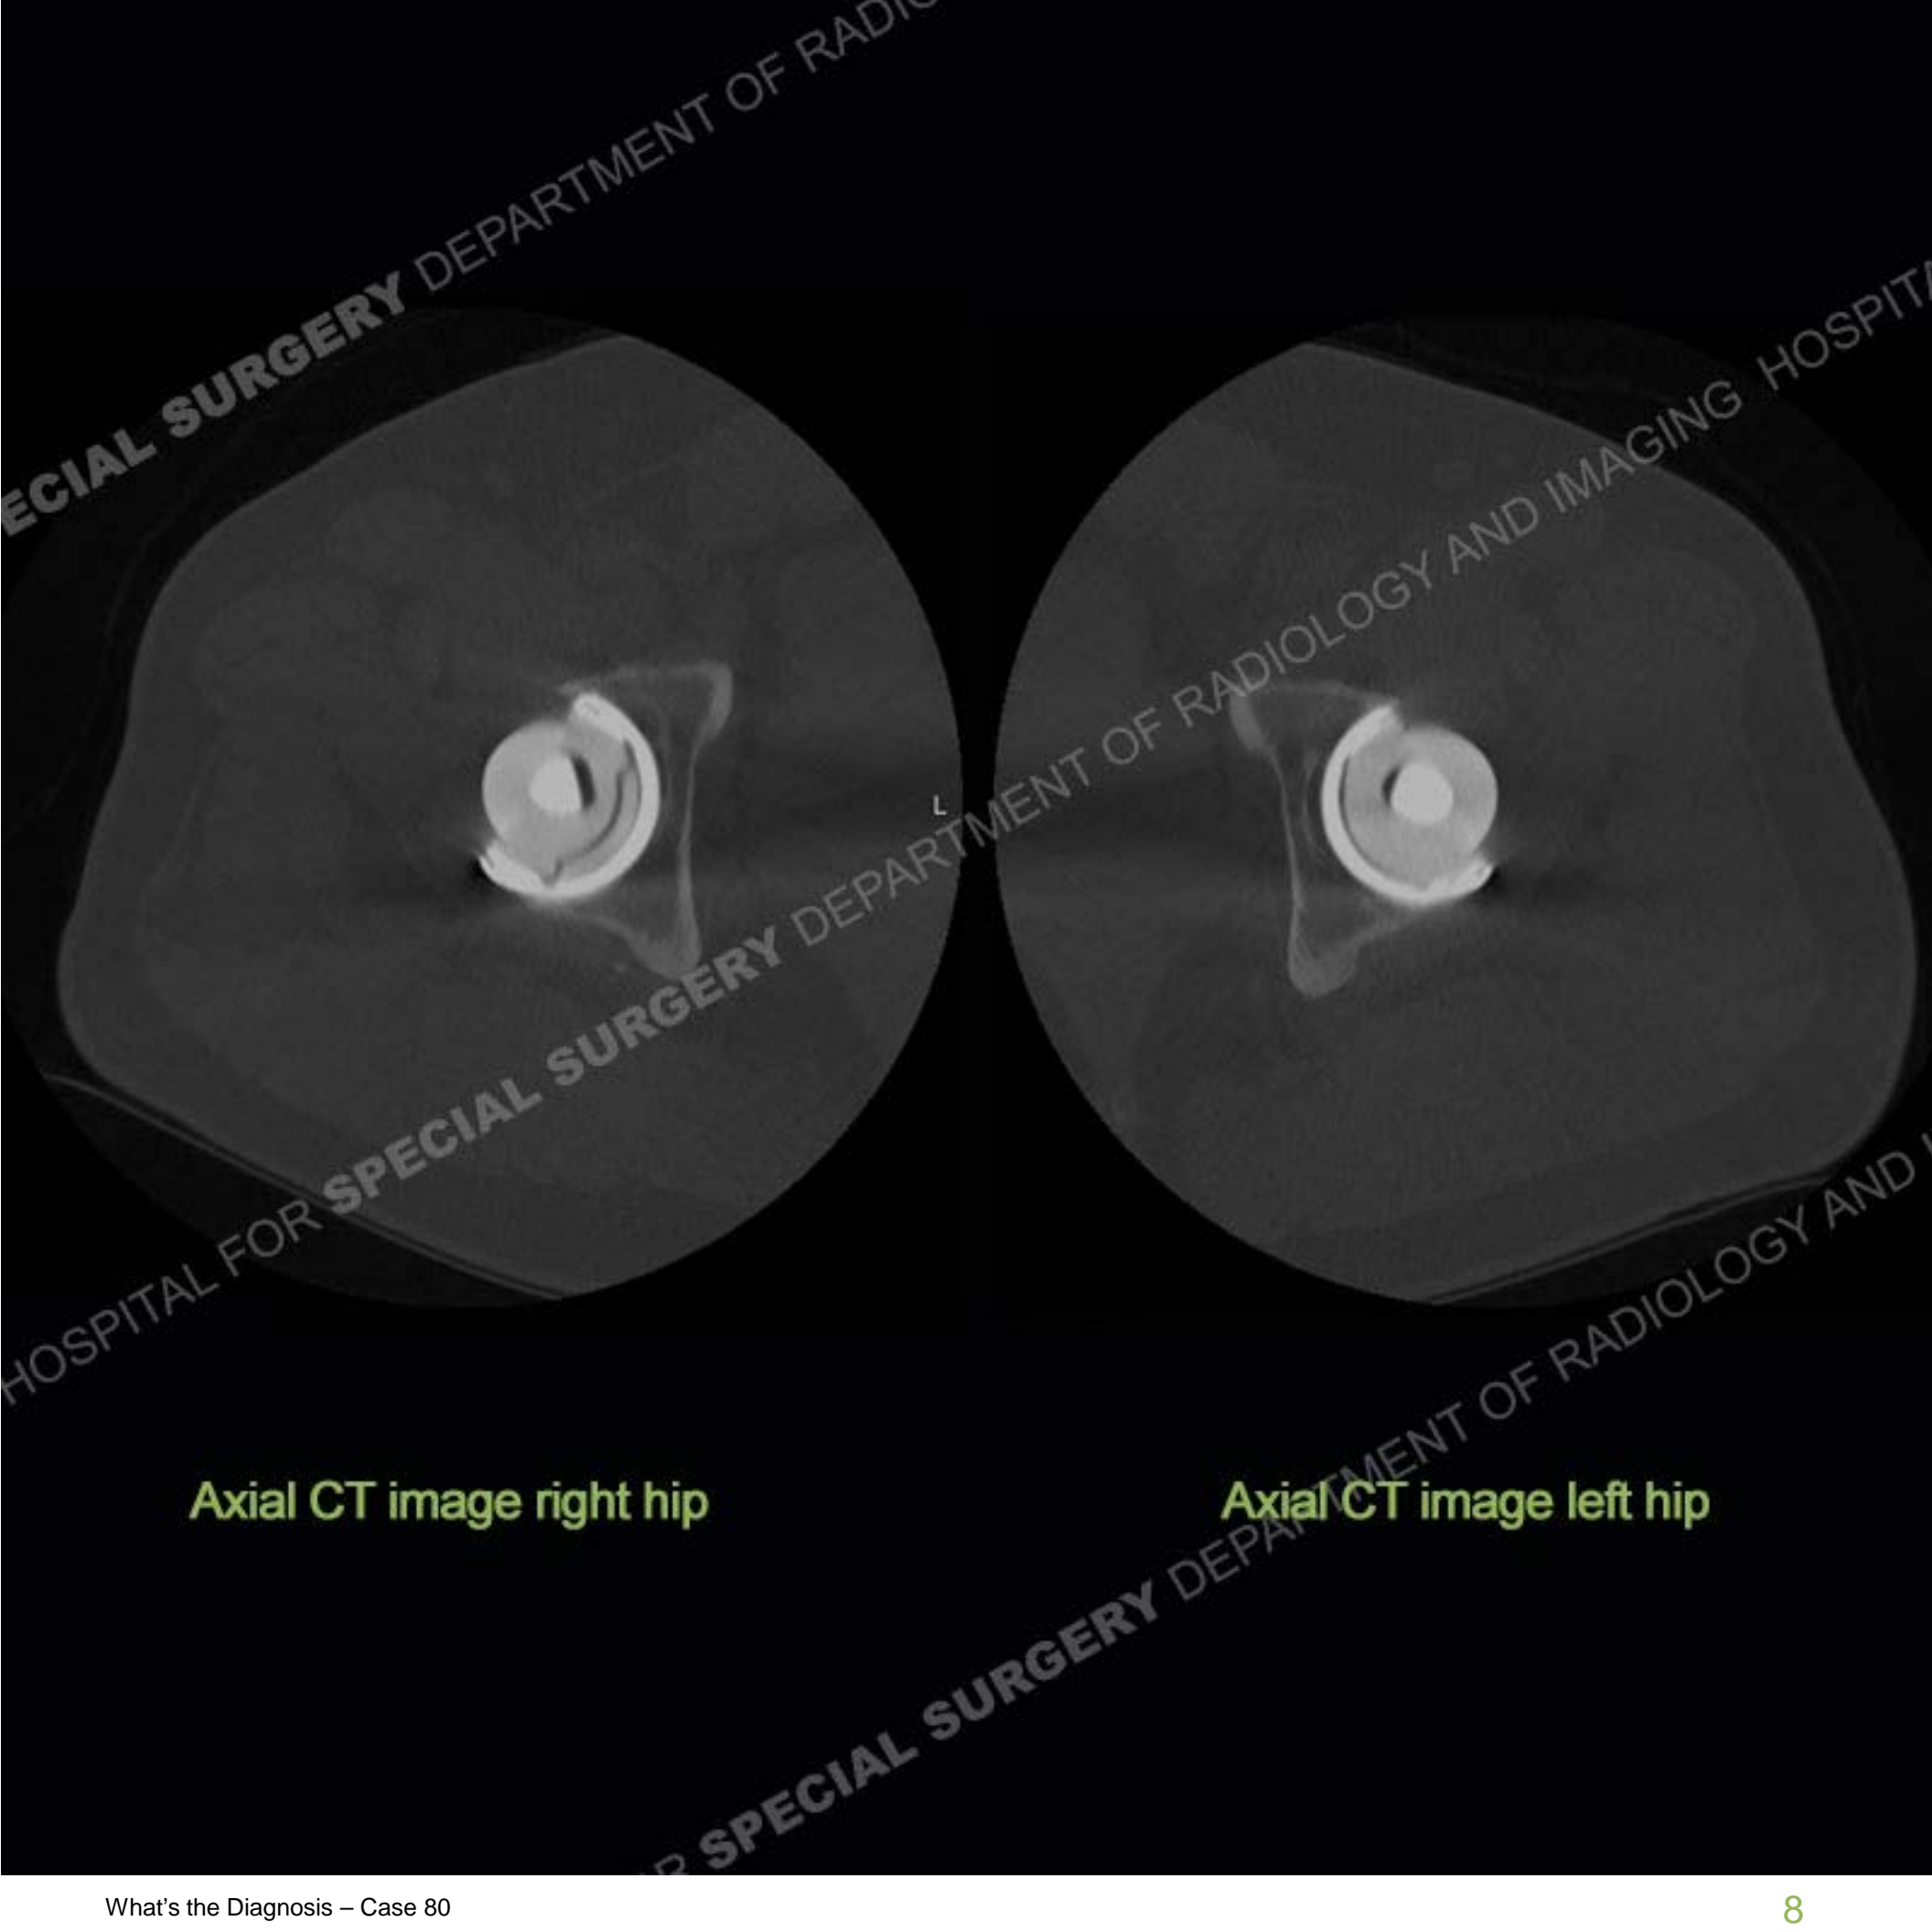
Axial CT image right hip

Axial CT image left hip

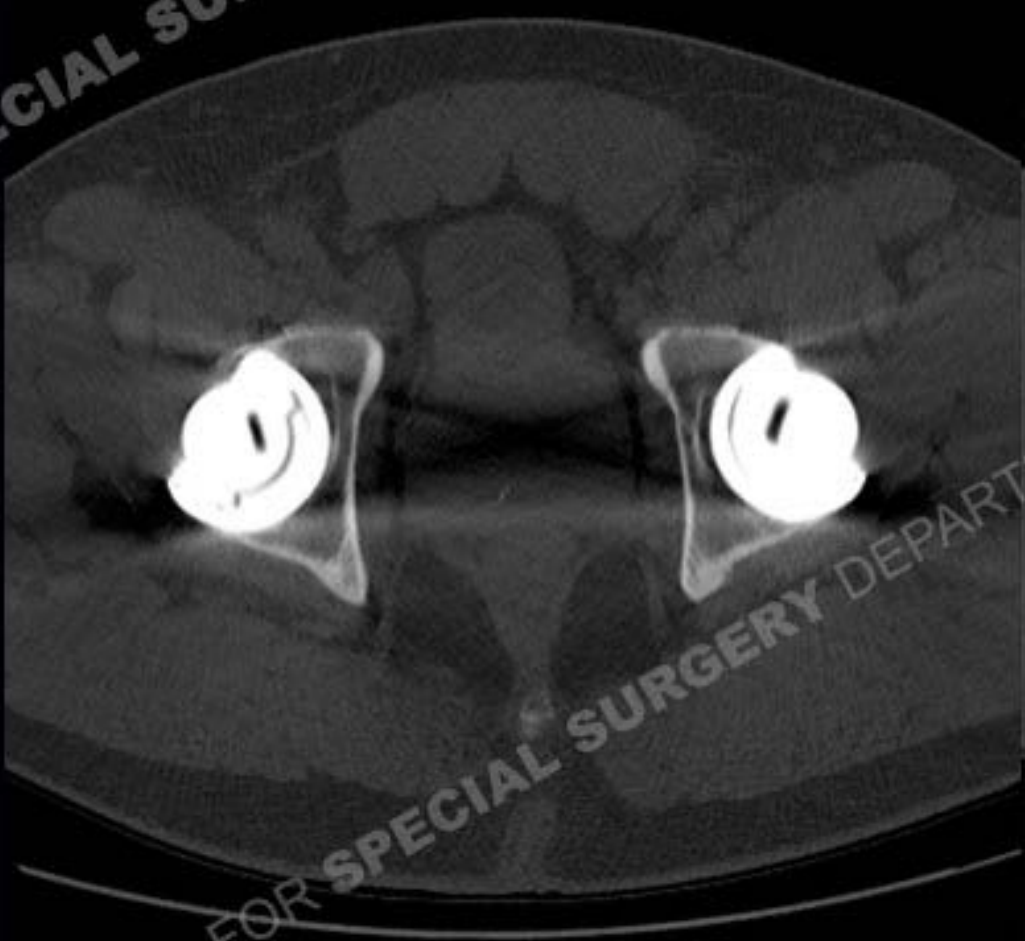
Axial CT with soft tissue window

In this case, there are no findings to be made on the radiographs or on the MRI examination. On the CT examination, there is a lucent line in the liner of the acetabulum. The relative difference in attenuation at the articulation of the total hips and the adjacent metal components indicates these are ceramic on ceramic (COC) total hip arthroplasties. Additionally, the axial CT images demonstrate the necessity of appropriate windowing and technique in being able to generate the appropriate diagnosis.

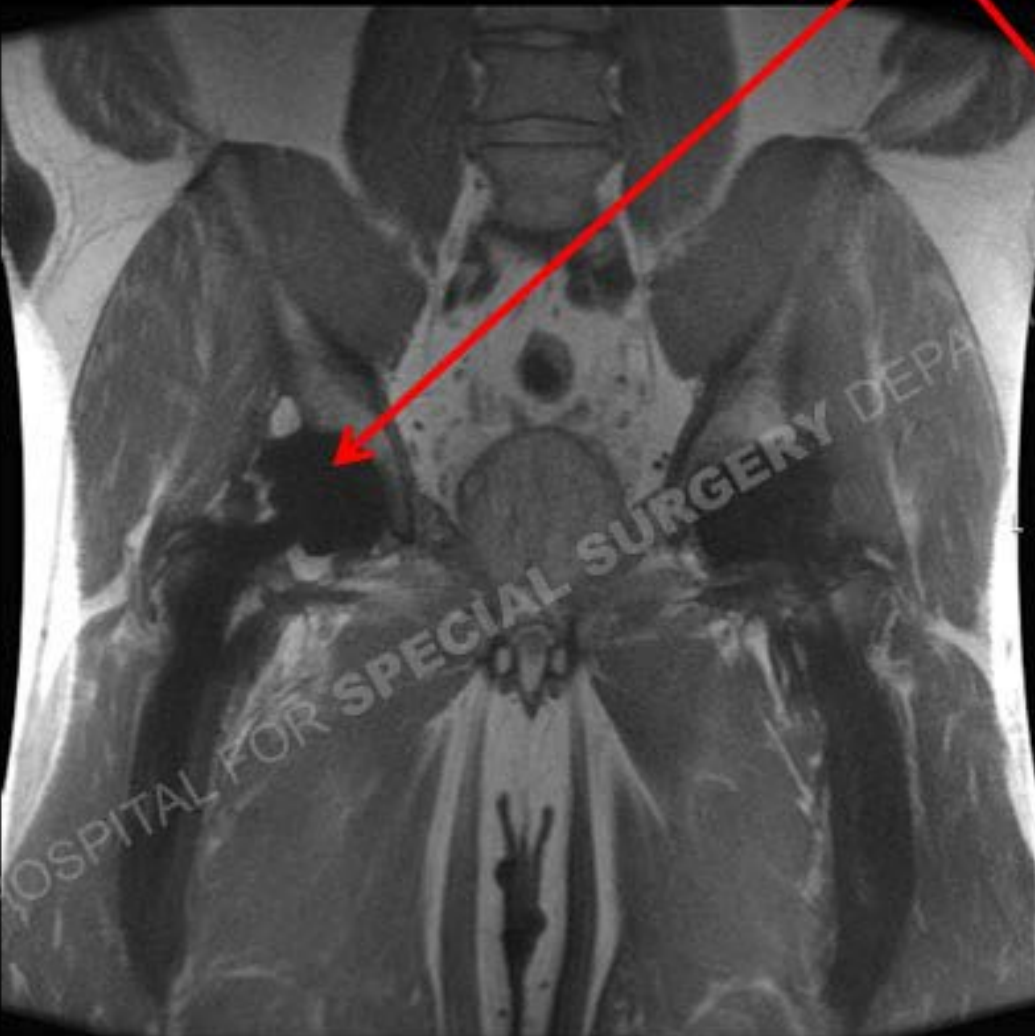
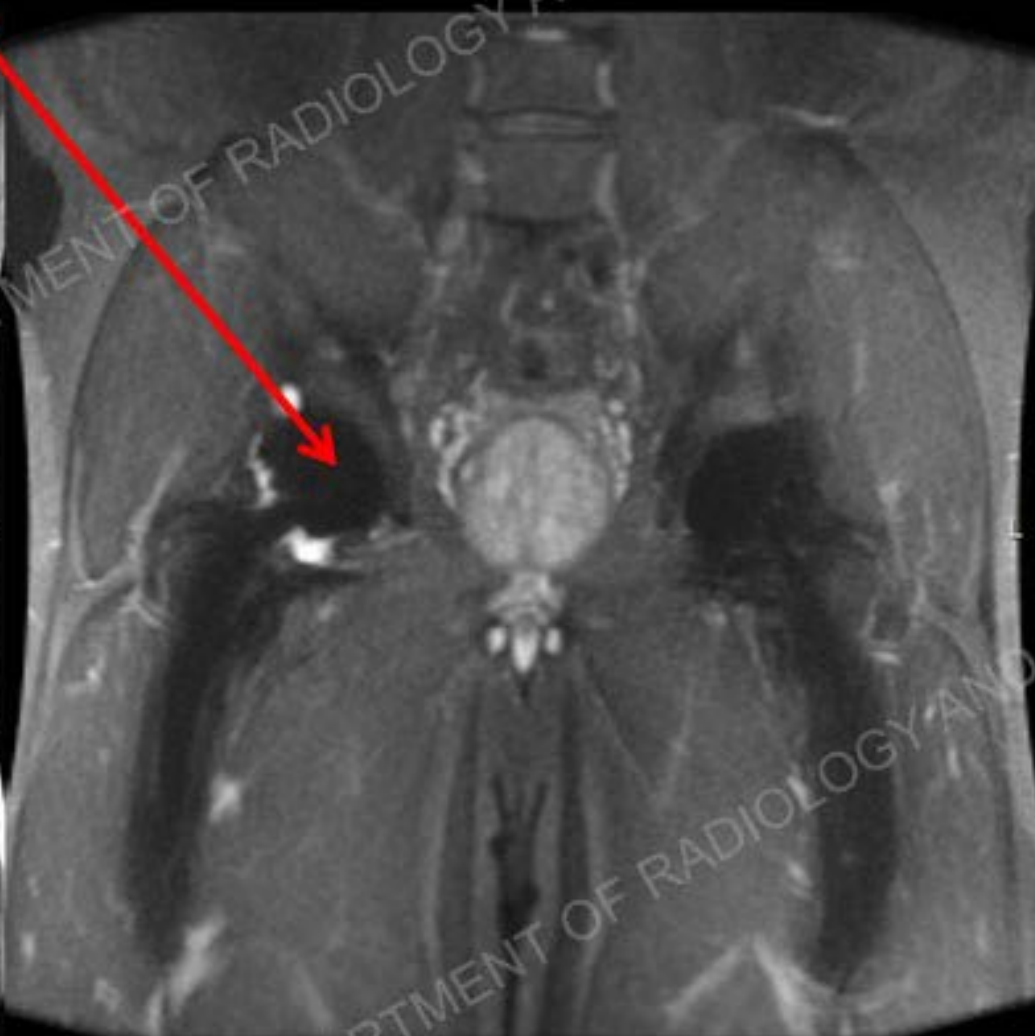
Lucent defect of ceramic liner of acetabulum

Normal articulation

A rare complication of a ceramic on ceramic total hip arthroplasty related to the brittle architecture of the ceramic components. Improvements have been made in the components but this complication does still present. It classically presents with a squeaking with ambulation but does not have to. This often signifies a non-displaced crack that can go on to a catastrophic fragmentation of the prosthesis. This complication necessitates revision as was done in this example.

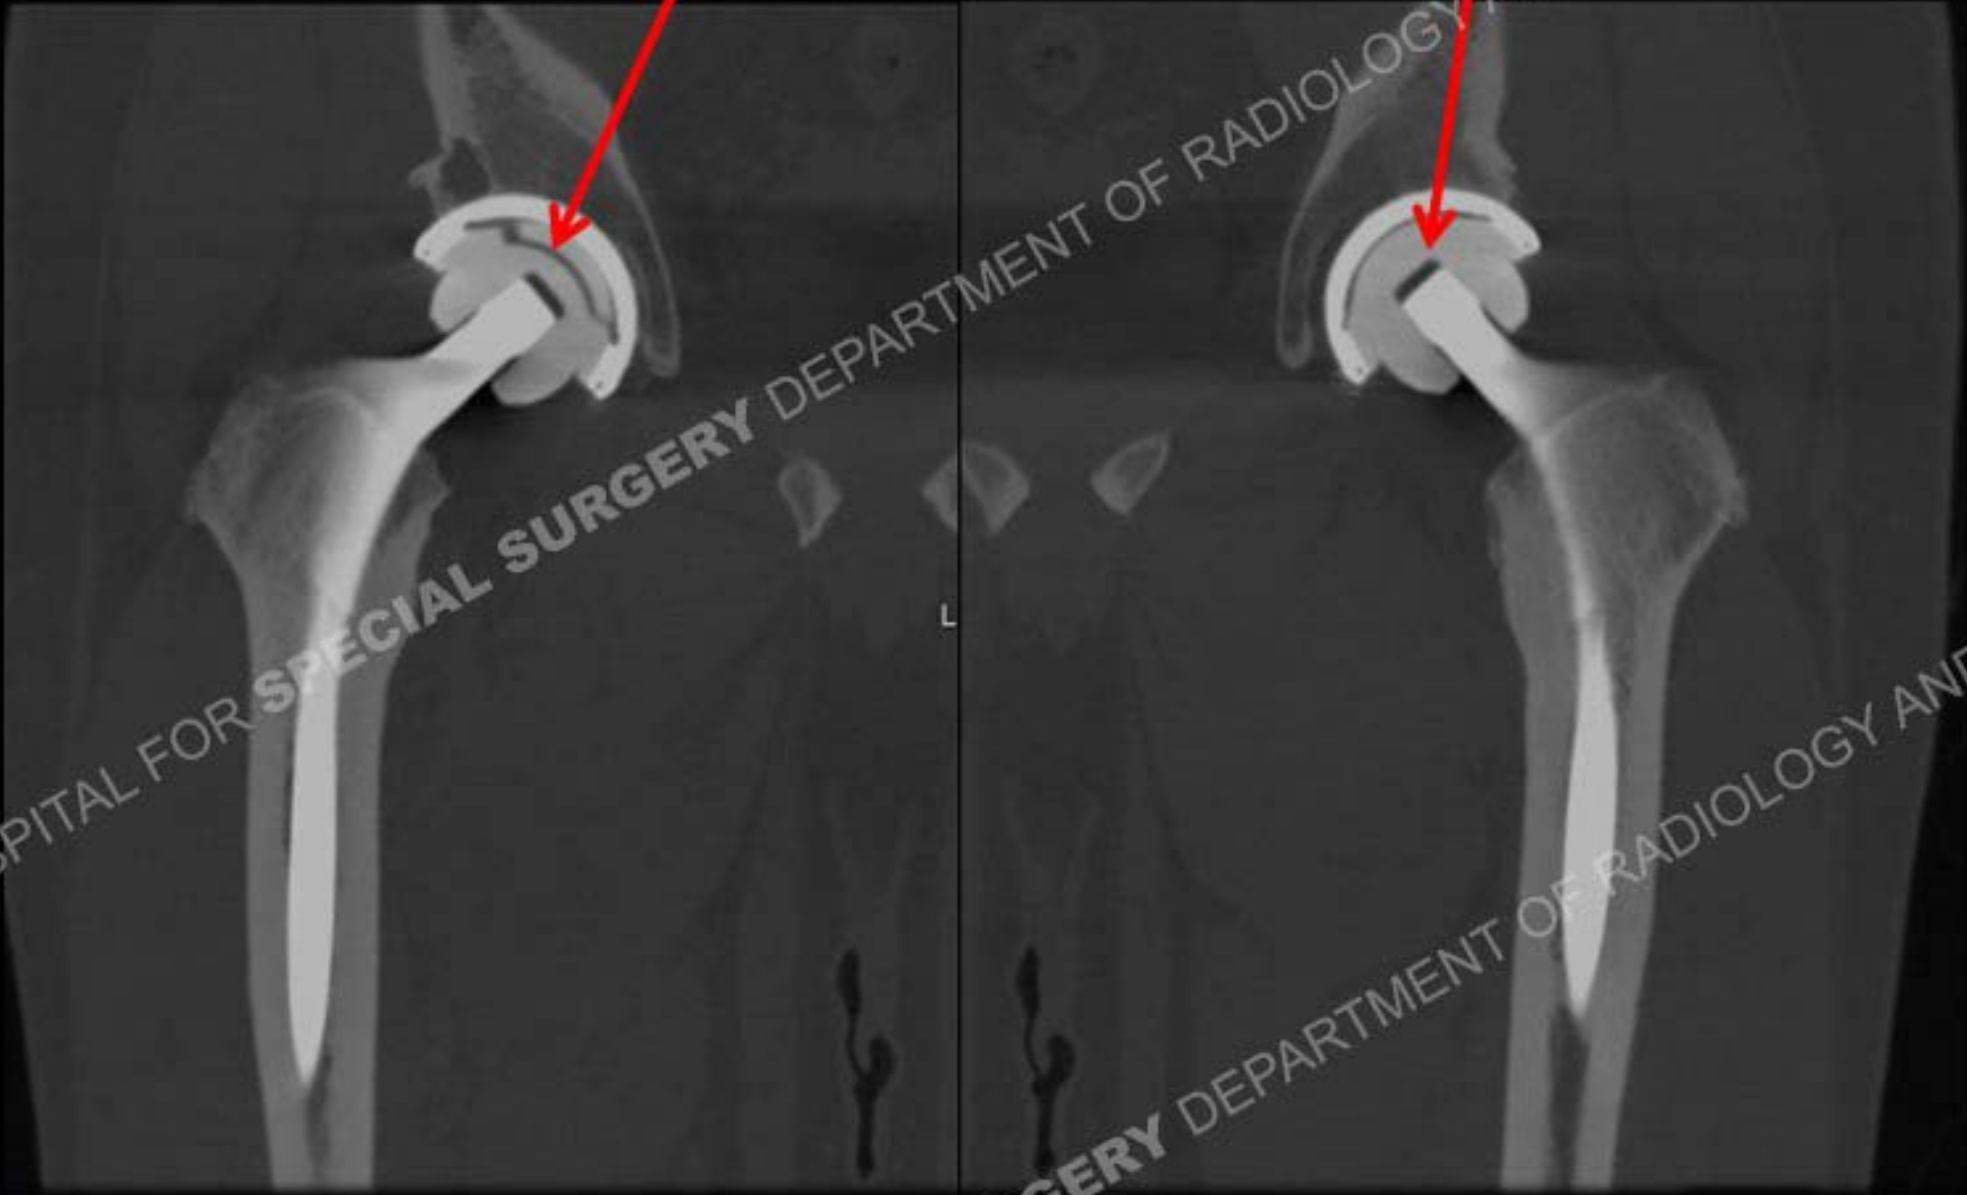
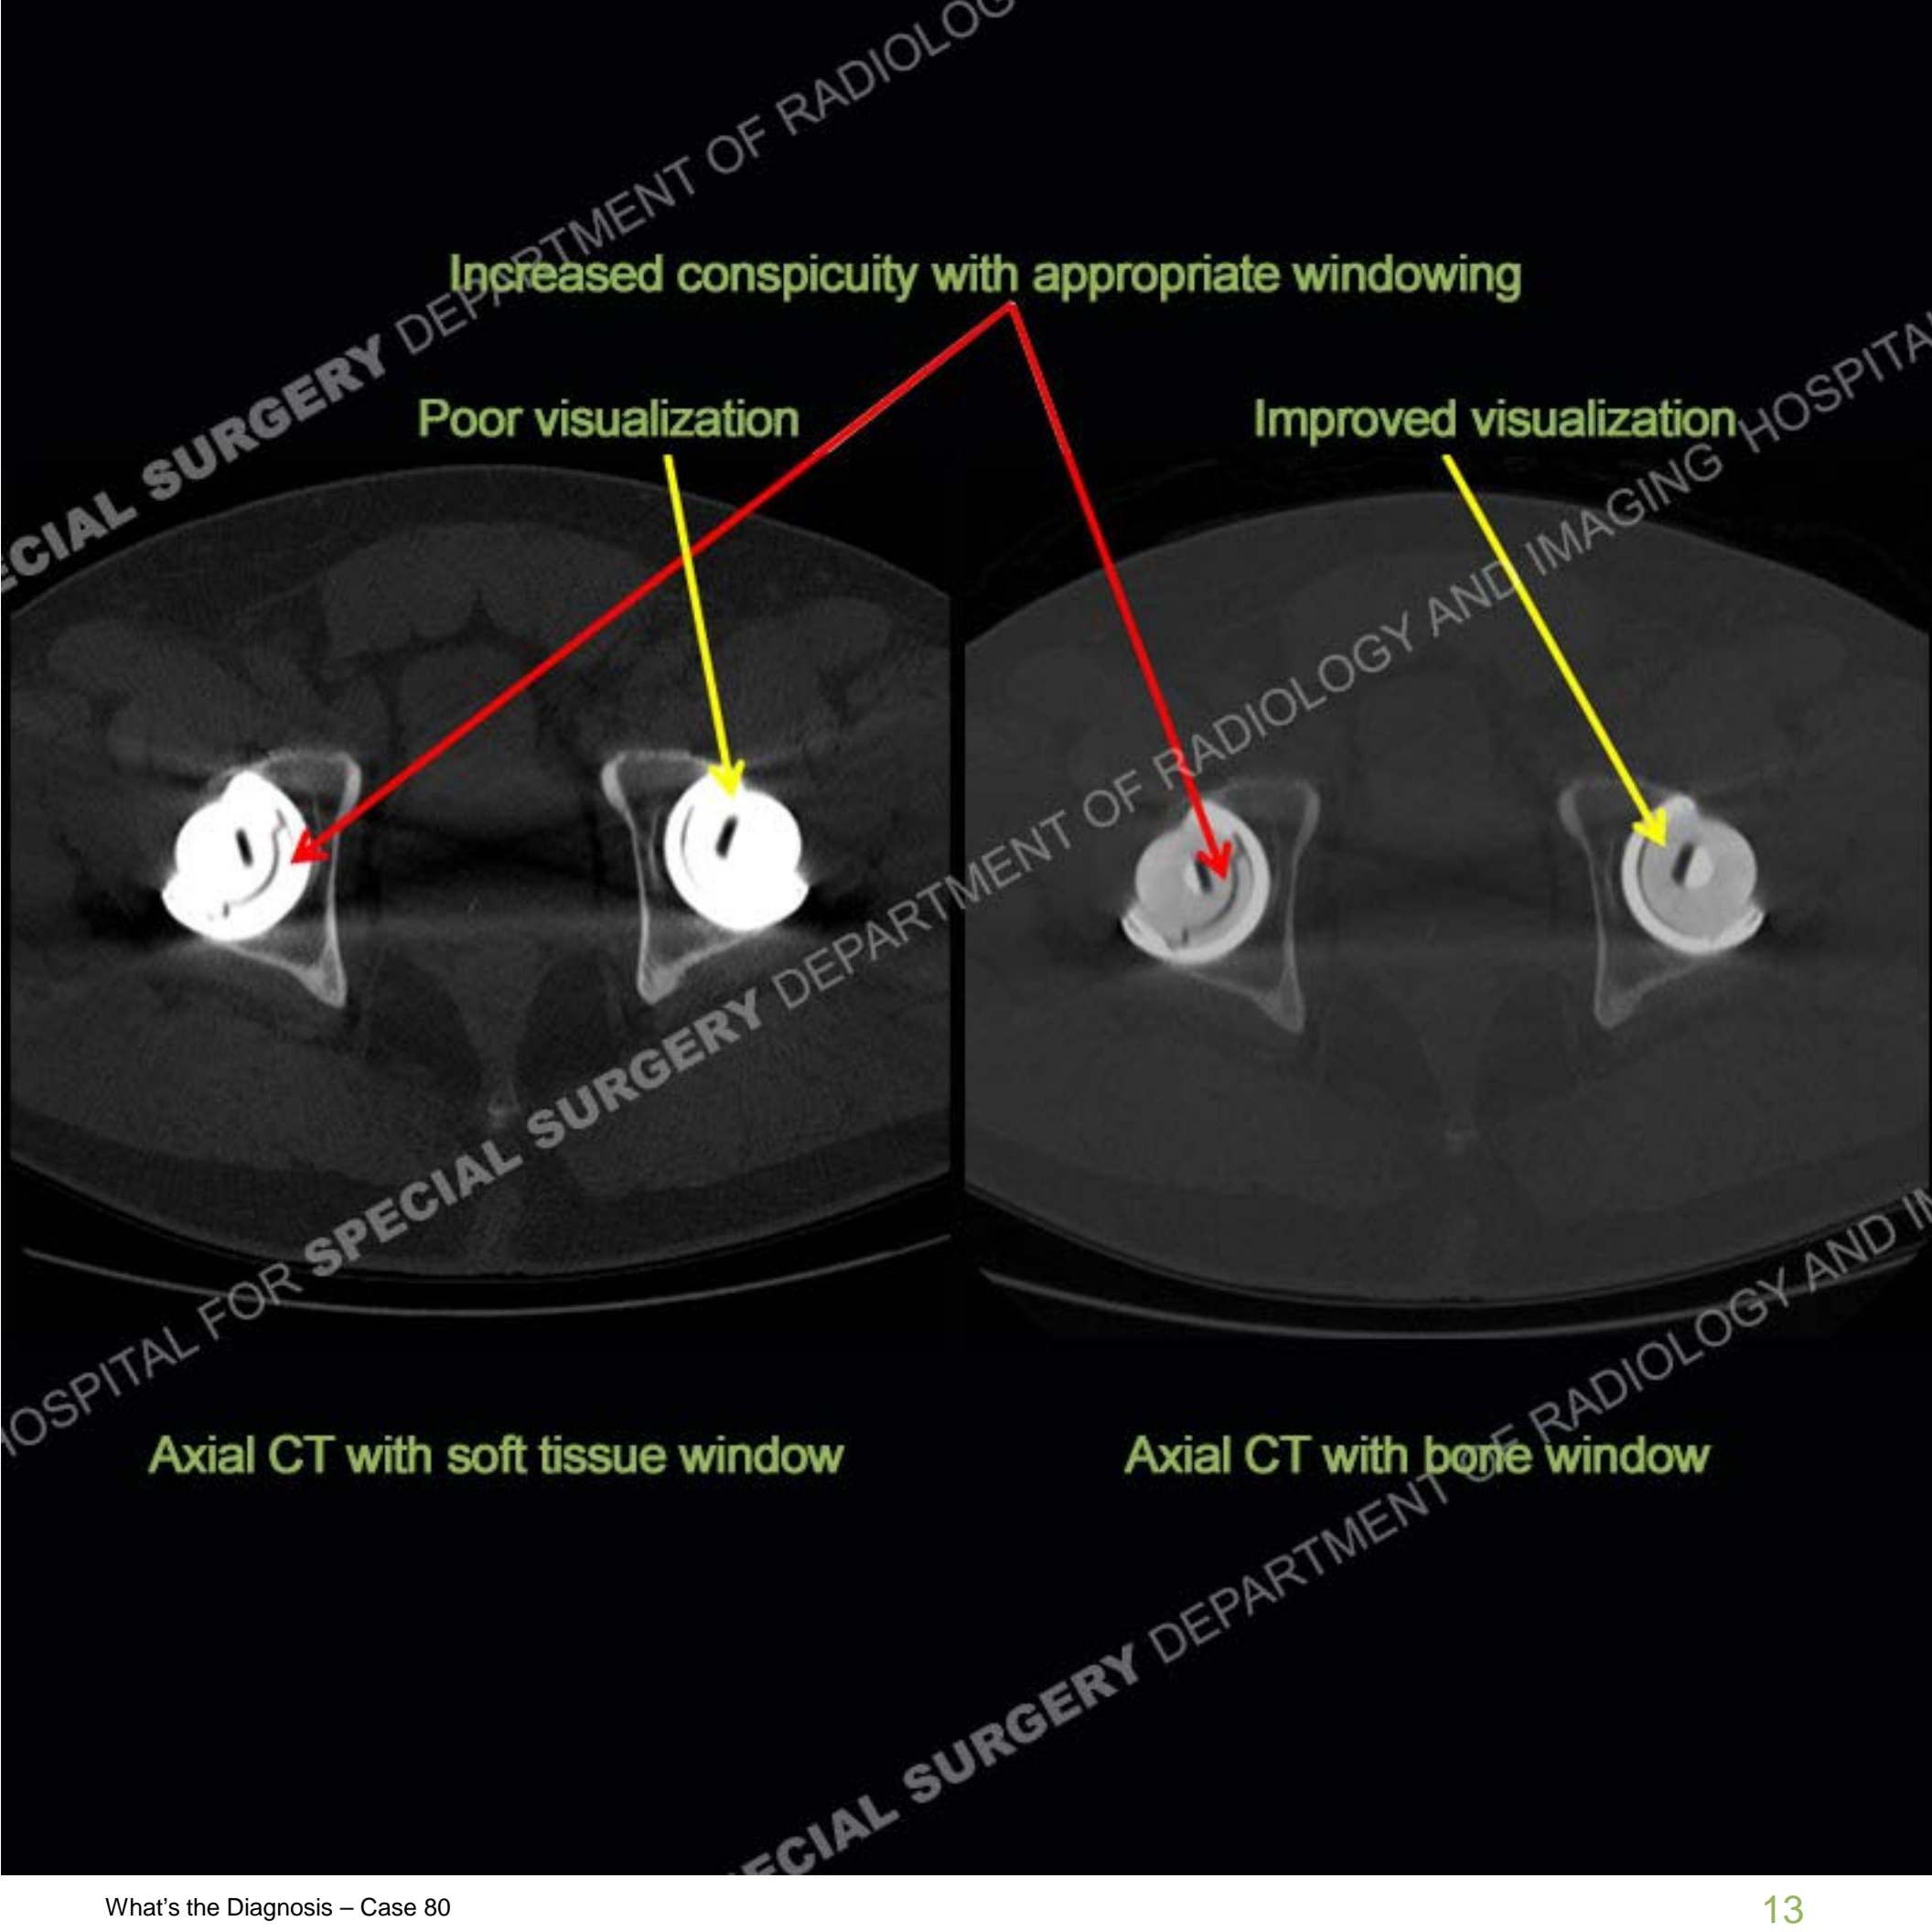
Increased conspicuity with appropriate windowing

Poor visualization

Improved visualization

Axial CT with soft tissue window

Axial CT with bone window

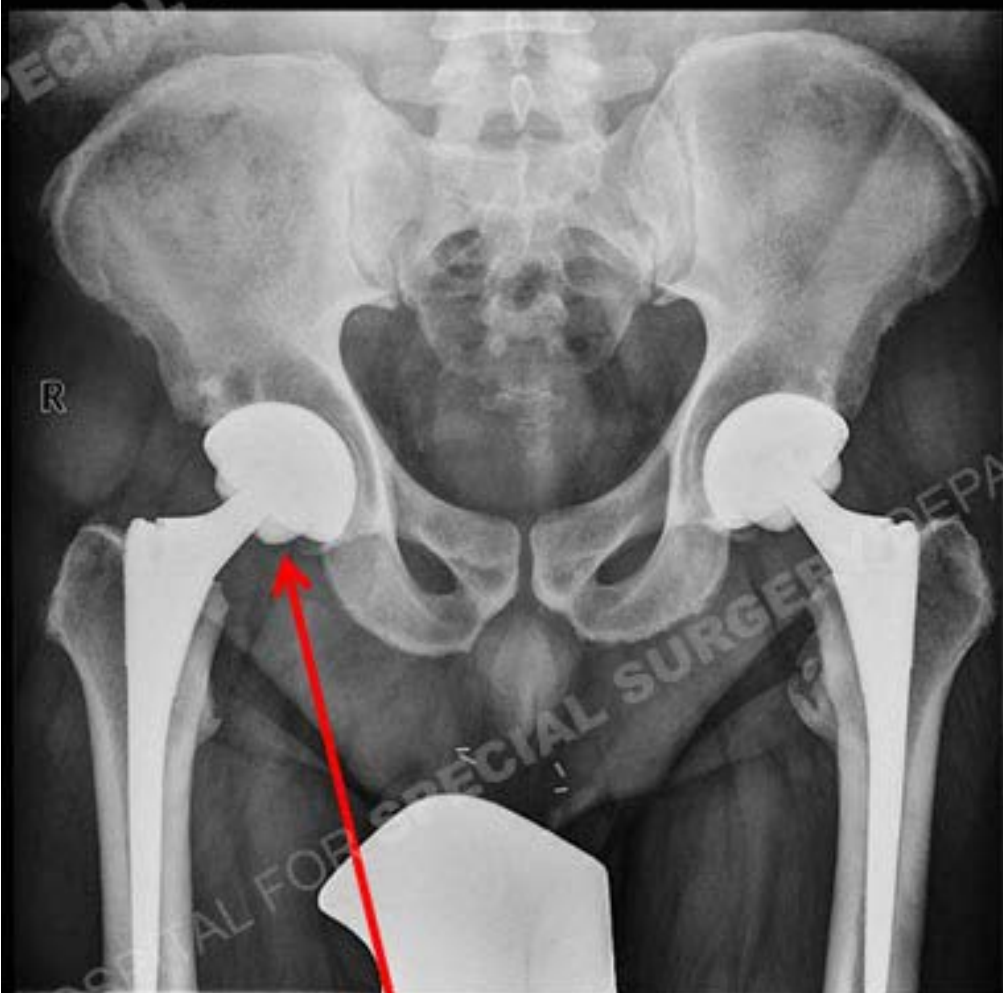
Primary

Degenerative subchondral cyst without change. Not an area of osteolysis

This case highlights a couple of other points. It is important to understand the limitations of any given radiology exam and frequently, no individual exam can answer every question. MRI, particularly with recent advances in artifact reduction, is an exquisite tool at diagnosing complications in THA but even that can not answer all questions. In this case the ceramic on ceramic articulation is better seen with a CT exam. However, both the technique at acquiring the exam and then reading the exam must be tailored in such a way to allow optimal visualization of the hardware. Also, comparison to older exams is helpful to help prevent erroneous diagnoses. In this case, a degenerative, subchondral cyst could be mistaken for a focus of osteolysis which may confound the clinical picture.

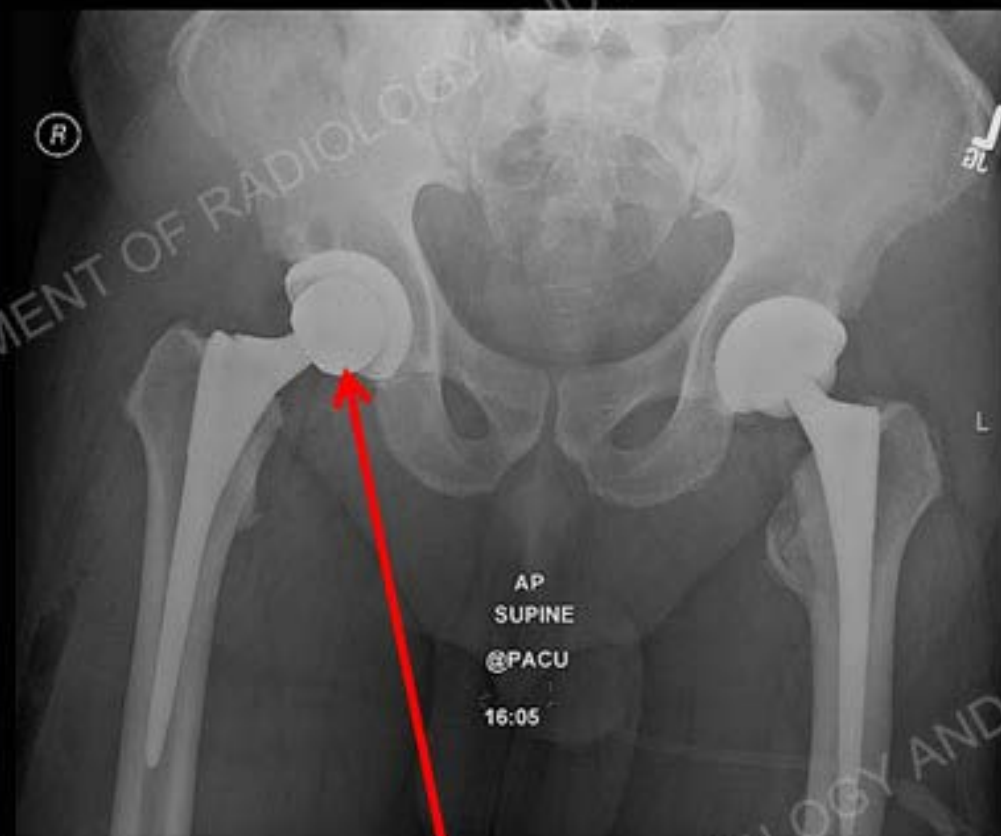
Revision with metal on poly THA
