**Limb Deformity Case Study #1:** Patient is a very active 6'3" tall 13 year old male who presented with complaints of a progressive knock knee (knee valgus) deformity.

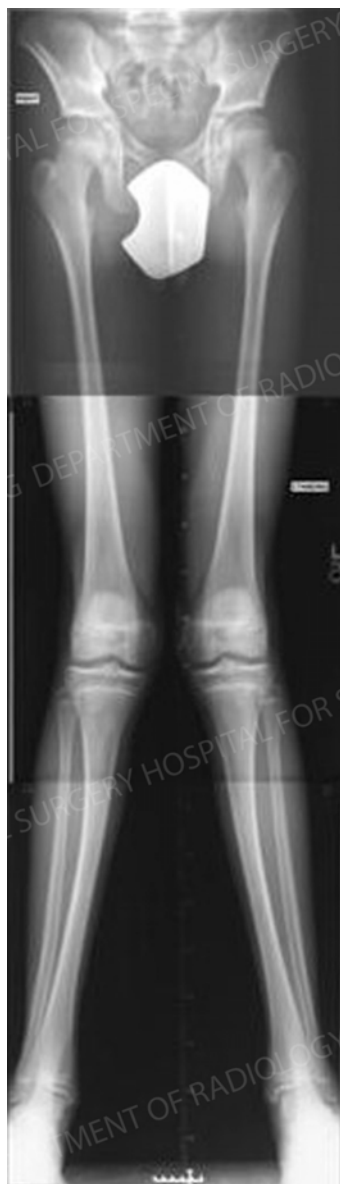
Figure 1: Pre-operative standing x-ray demonstrating lower extremity alignment.

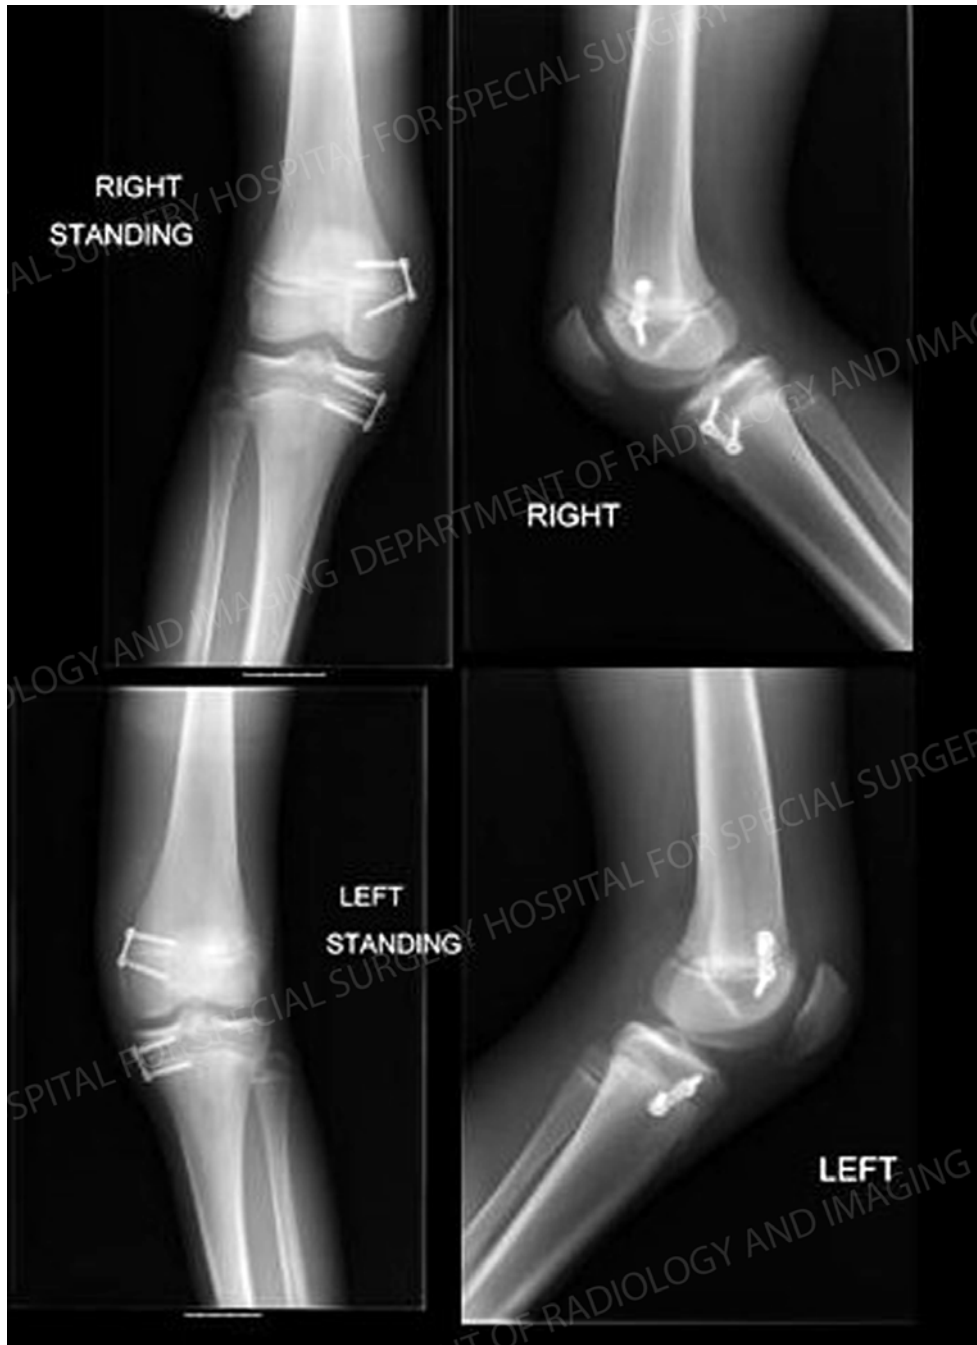
Figure 2: Post-operative x-rays -- knee x-rays demonstrating surgical hemiepiphysiodesis utilizing an eight plate.

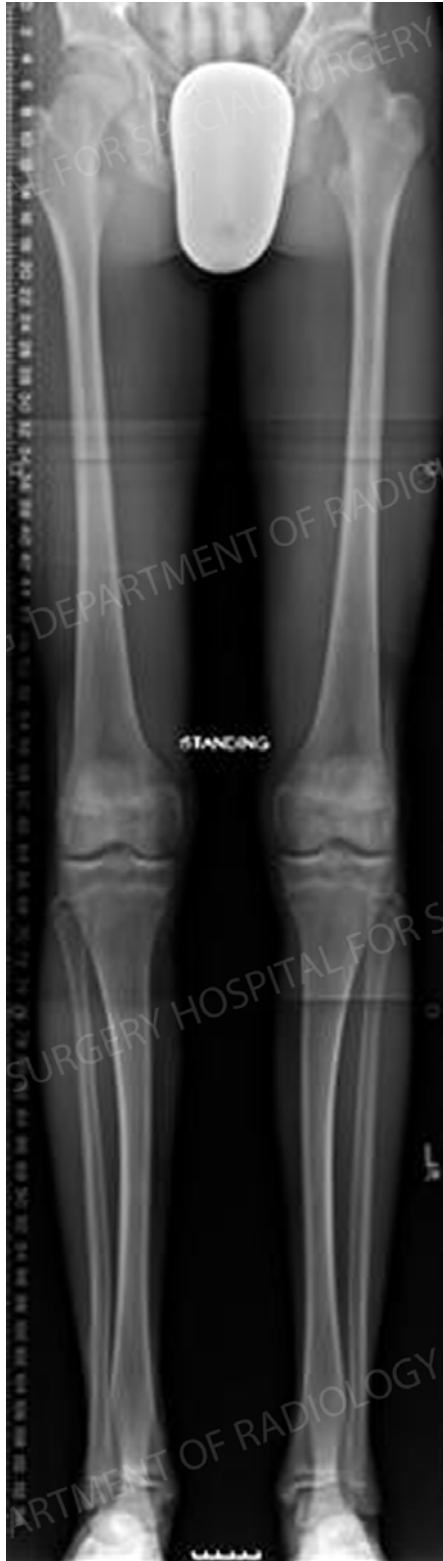
Figure 3: Post-operative x-rays demonstrating leg alignment after surgical correction and removal of the eight plates.
